Appendix N
Chatfield Marina
Reallocation Impact Assessment Report

Reallocation Impact Assessment Report

Chatfield State Park - Littleton, CO

February 2011

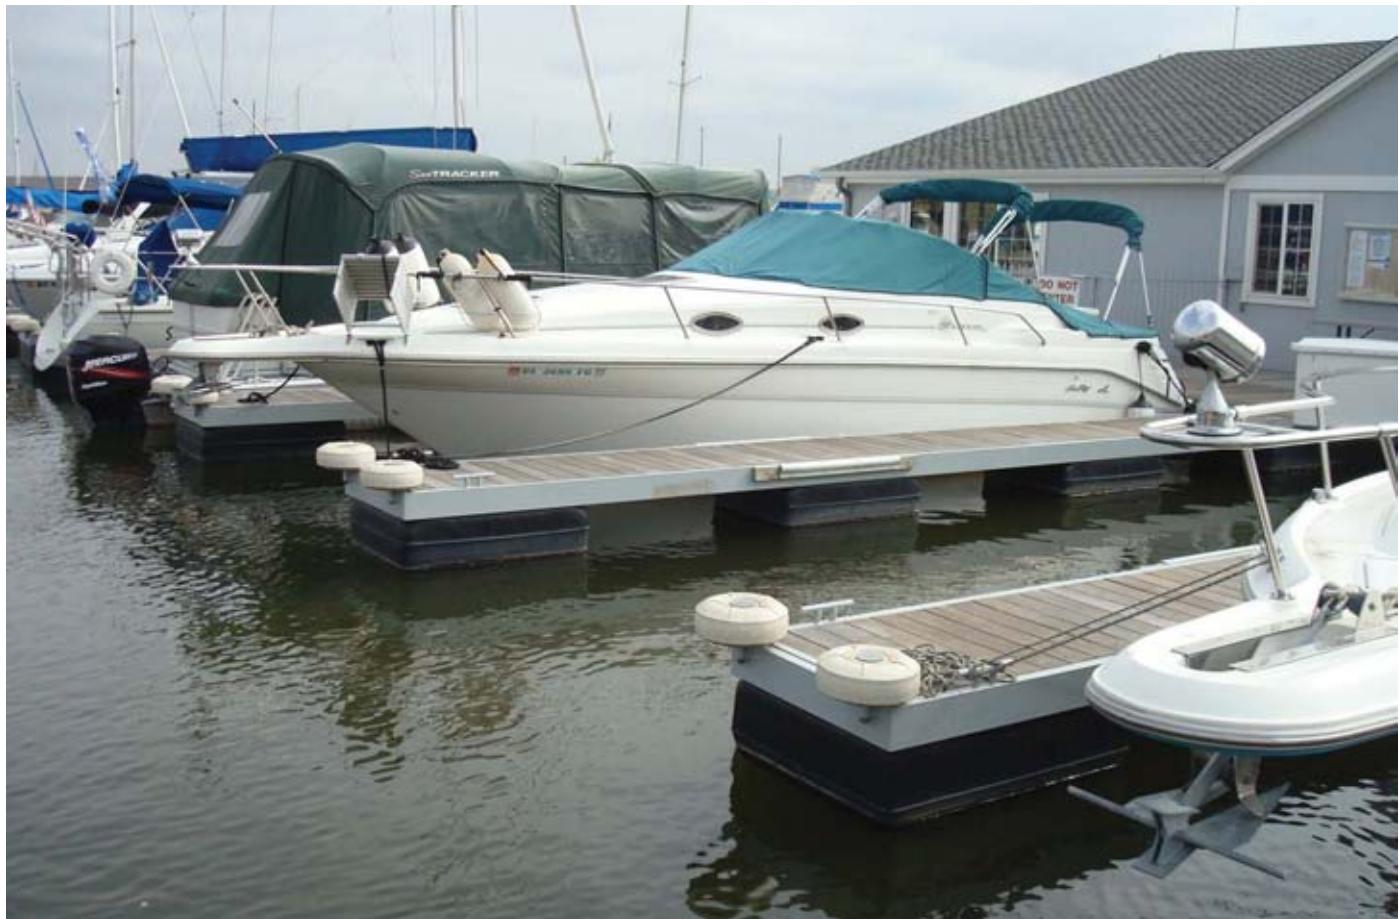
3-2 Floating Docks Side View

The existing floating dock system was built by the operator incrementally over the last 27 years. The dock system consists of welded tube steel frames, polyethylene encased polystyrene floats, and Ipe (sustainable Brazilian hardwood) decking. The frames have field welded connections along the mainwalks and hinged connections at finger and secondary platform connections. The shallow nature of the tube frames results in significant flexure (bounce) of the dock system when subject to pedestrian loads. The frames, floats, and decking are all in excellent condition and have been carefully maintained.

The system is more sensitive to wave and wake action than modern factory manufactured systems and requires wave and wake protection along with protection from moving ice.

Replacement of the dock system with a new one will allow for a more robust system that will withstand the more exposed conditions and the increased loadings from wave and ice conditions.

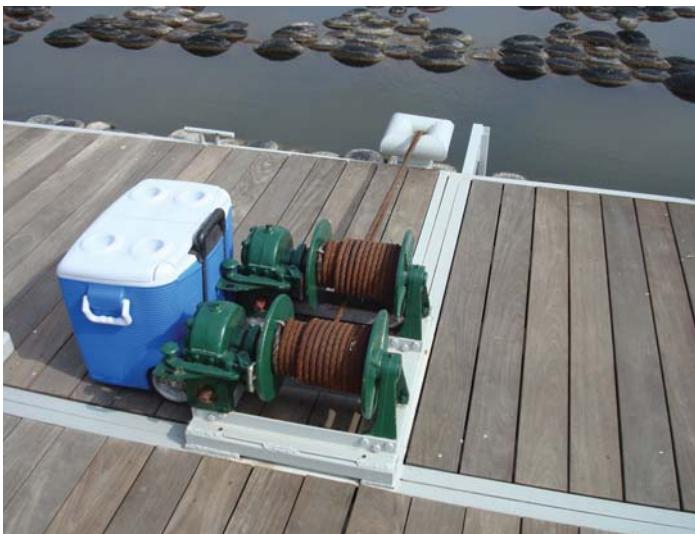
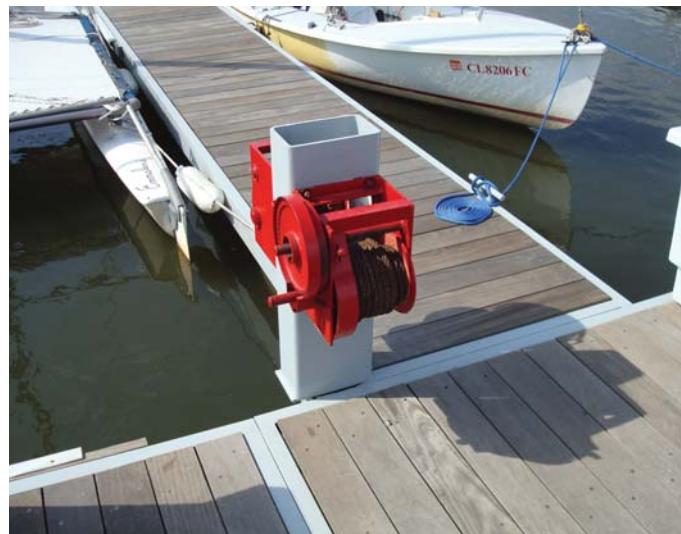
3-4 Cable and Winch Systems

The marina docks and the breakwater are held in place using a cable and winch system. The system is anchored to the bottom of the reservoir with a combination of concrete anchors and helix anchors. The anchors are installed and maintained by the operator using a custom spud barge. The 99 anchor point system requires occasional movement and adjustment by the operator. Discussions with the operator reveal that the anchor system, like the dock system has been incrementally expanded and modified over the years.

The anchor system is limited in its current configuration to the normal range of elevations plus occasional flood elevations to 5,472'+-. The cables associated with the anchor system at the outboard walkway cross the surface of the decking at some locations which result in a significant tripping hazard. The anchorage system in place today was developed by the operator and represents the current system and conditions. Changes in either will probably require a complete reanalysis of the system to meet the new conditions.

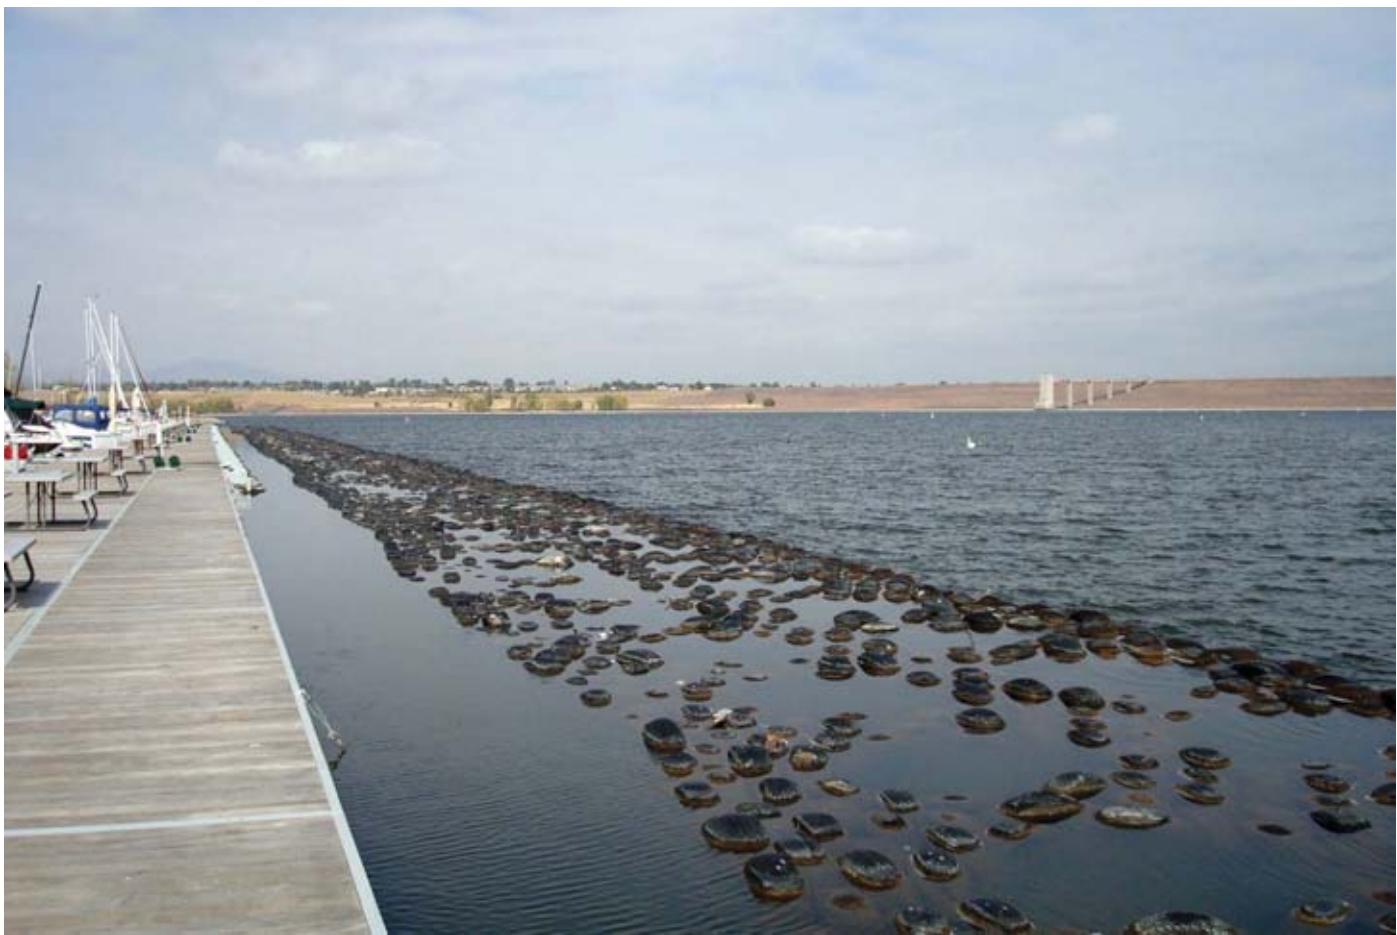
3-5 Floating Tire Breakwater

The north and west edges of the marina are vulnerable to wave and wake action from the main body of the lake. Additionally, spring thaw results in significant ice movement on the lake. The marina operator has installed a floating tire wave attenuator to protect the marina docks along these edges. The two part attenuator has an inner barrier attached to the outer edge of the docks. The outer 18' wide mat of tires is anchored independently of the floating docks and is separated by approximately 6' from the inner system on the north and 2' on the west. The anchorage of the floating breakwater is not adjustable.

The system was popular for marinas in the 1980's as a lower cost alternative to fixed breakwaters or floating concrete structures. Although the system is not very attractive, it has worked very well over the years. Without the protection of the wave attenuator, it is likely that this dock system could experience increased damage from wave and ice impacts.

Additionally, since the current floating tire breakwater anchorage system is not adjustable, this system would not function as intended at the FWSP and would be submerged under flood events. A replacement or major reworking of the breakwater would be expected for the new operating conditions.

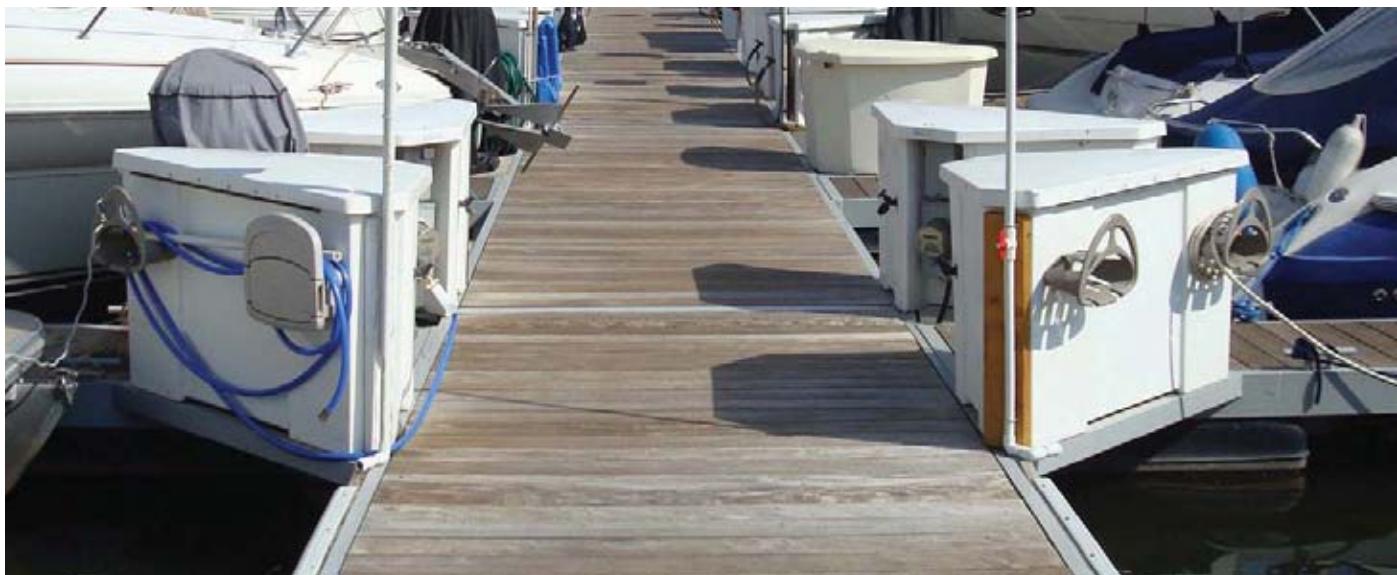
3-6 Dock Utilities

The slips that have power also have potable water supplies. There is no fire protection system in the marina. Fire cabinets and extinguishers are located throughout the marina docks to provide a nominal level of fire abatement capability.

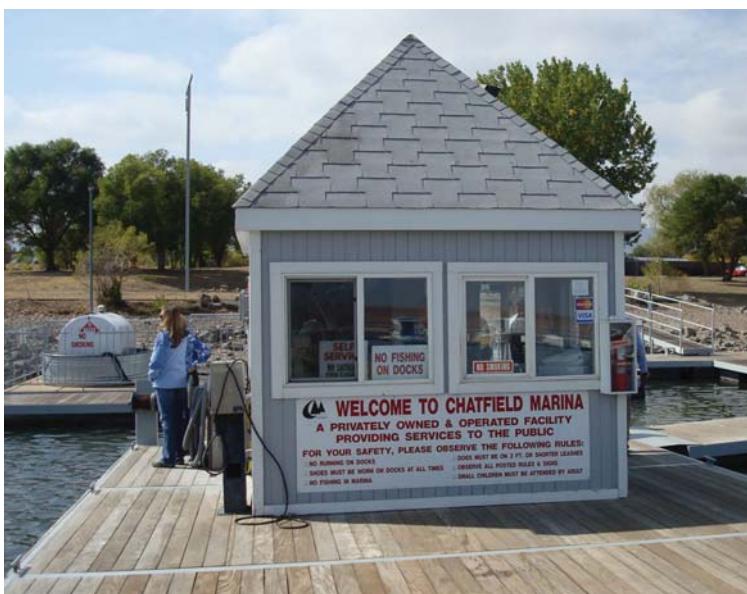
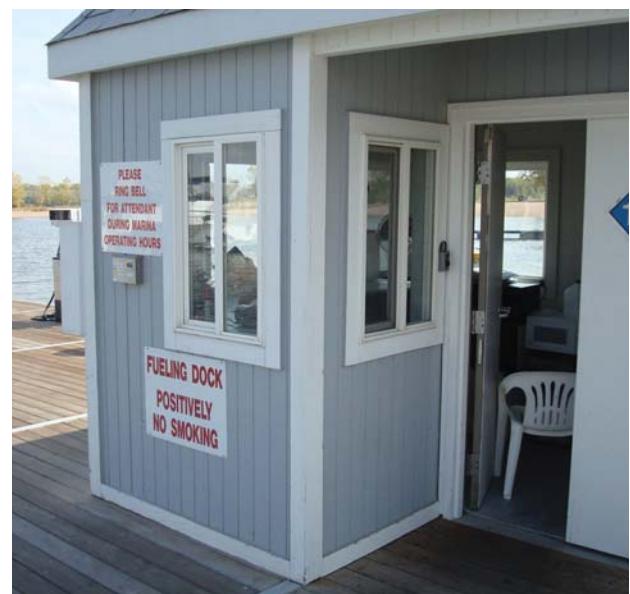
3-8 Fuel Hut

The marina has a 2,000 gallon gasoline only capacity for marine fueling. This is provided by four 500 gallon above ground storage tanks (AST) each within galvanized steel containment tanks floating on dock platforms. Filling of the tanks is accomplished by the tanker man dragging the fill line down the gangway and manually filling each tank separately. The tanks are connected and they feed the two fuel dispensers on the fuel dock. There is no diesel fuel available.

A replacement for the existing floating platform based office, convenience store, and restaurant is recommended. The fuel system should be modified to provide USTs above the 50 year flood level. This would simplify the tank fill procedure and would increase safety for the facility. Replacing the fuel system with a system similar to existing was discarded since, the distance from the new roads to any dock mounted AST would be impractical in either of the proposed alternatives.

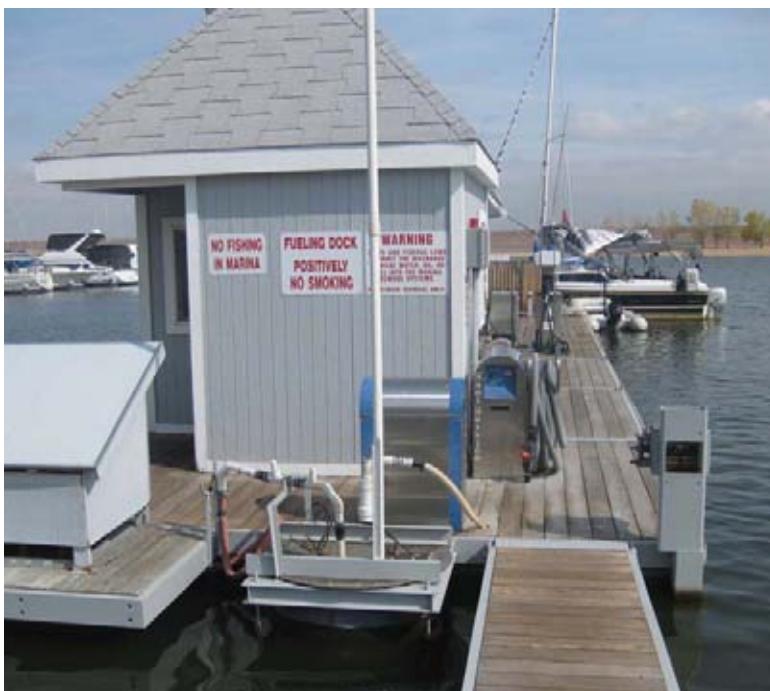
3-10 Pump Out

The marina fuel dock facility has the capability to pump out type 3 toilet facilities (holding tanks) and type 1 waste buckets. The facility is in very good condition and is used regularly.

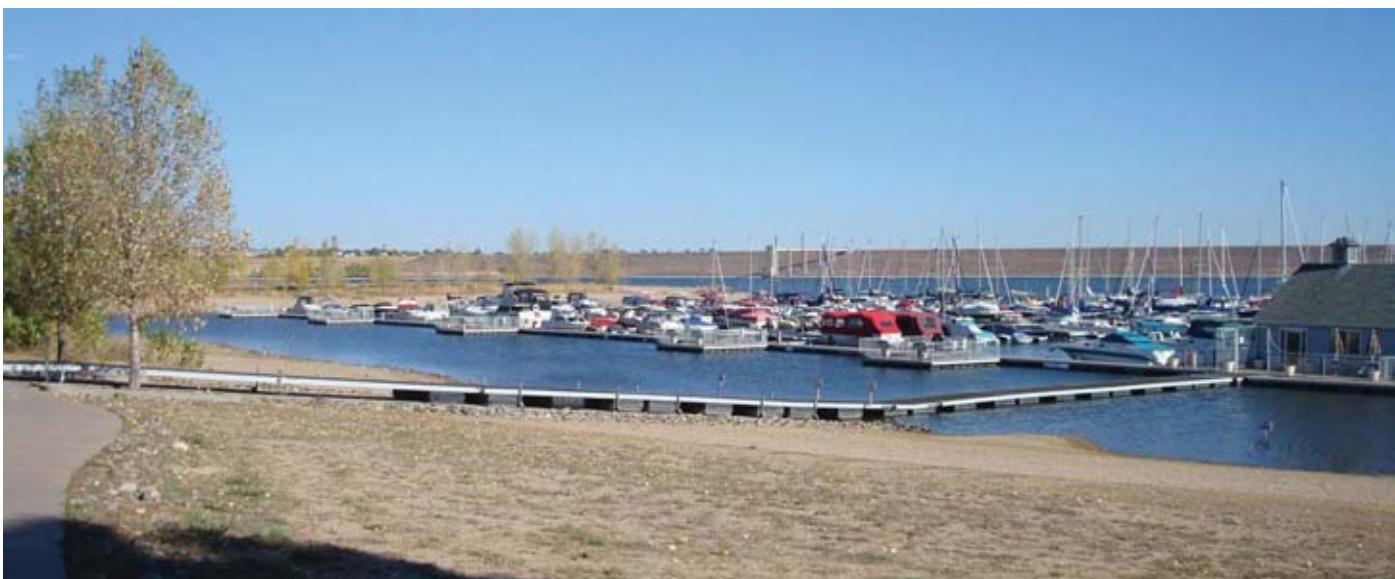
3-13 Main Gangway to Marina

The primary access to the floating marina is by a 150' long articulated floating walkway that rests on a concrete accessway during low water conditions. The gangway functions until the water elevation reaches 5440'. No security gates are provided on the gangway, but access is through a gate located on the floating restaurant platform.

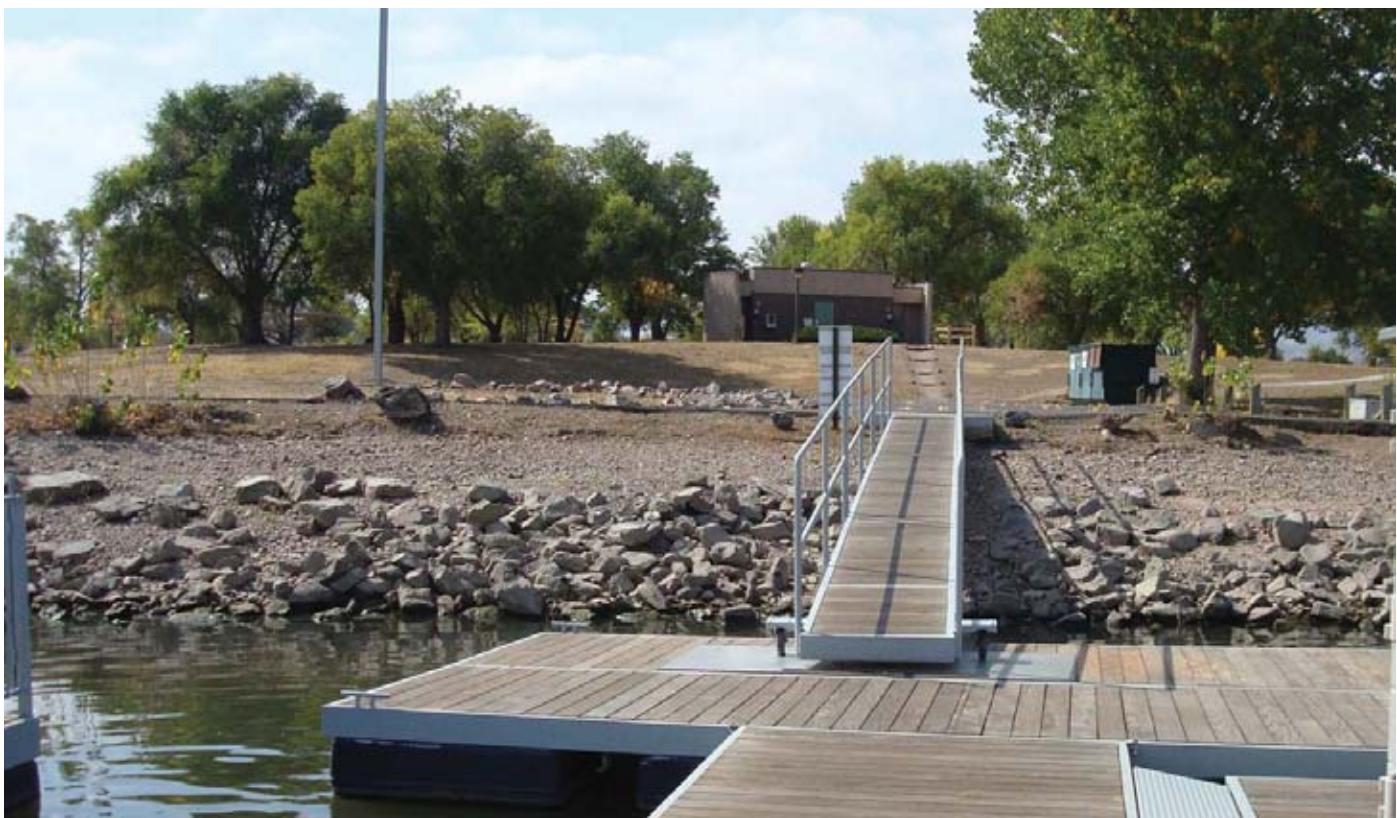
3-15 Fuel Dock Gangway

A secondary access to the docks is located at the fuel dock. This gangway provides restroom, trash receptacle and parking lot access to the boaters and allows the tanker man a means of access during the fueling evolution. The gangway is relatively short and may become uncomfortably steep during low water conditions.

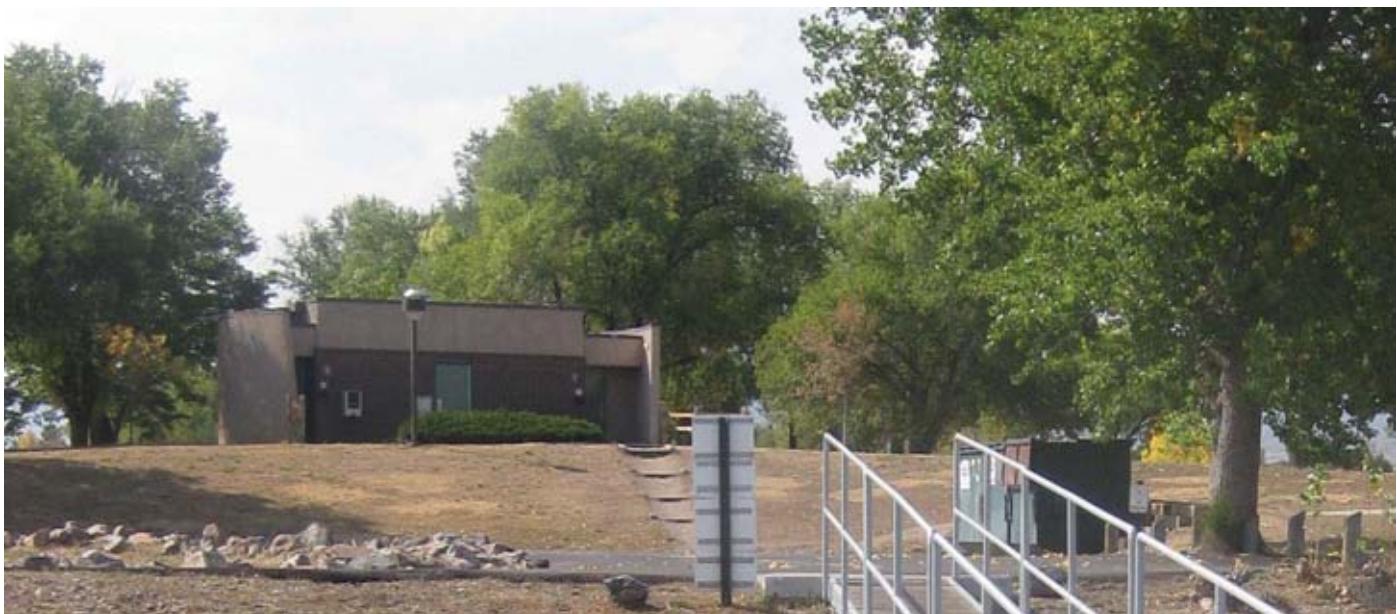
3-16 Upland Restrooms

No upland restrooms are directly maintained by the marina operator. There are two state park restroom facilities near the marina parking areas, one to the south and another just east of the parking lots. Both are plumbed and connected to the sanitary system. Both restrooms are situated below the proposed 5,444' inundation line.

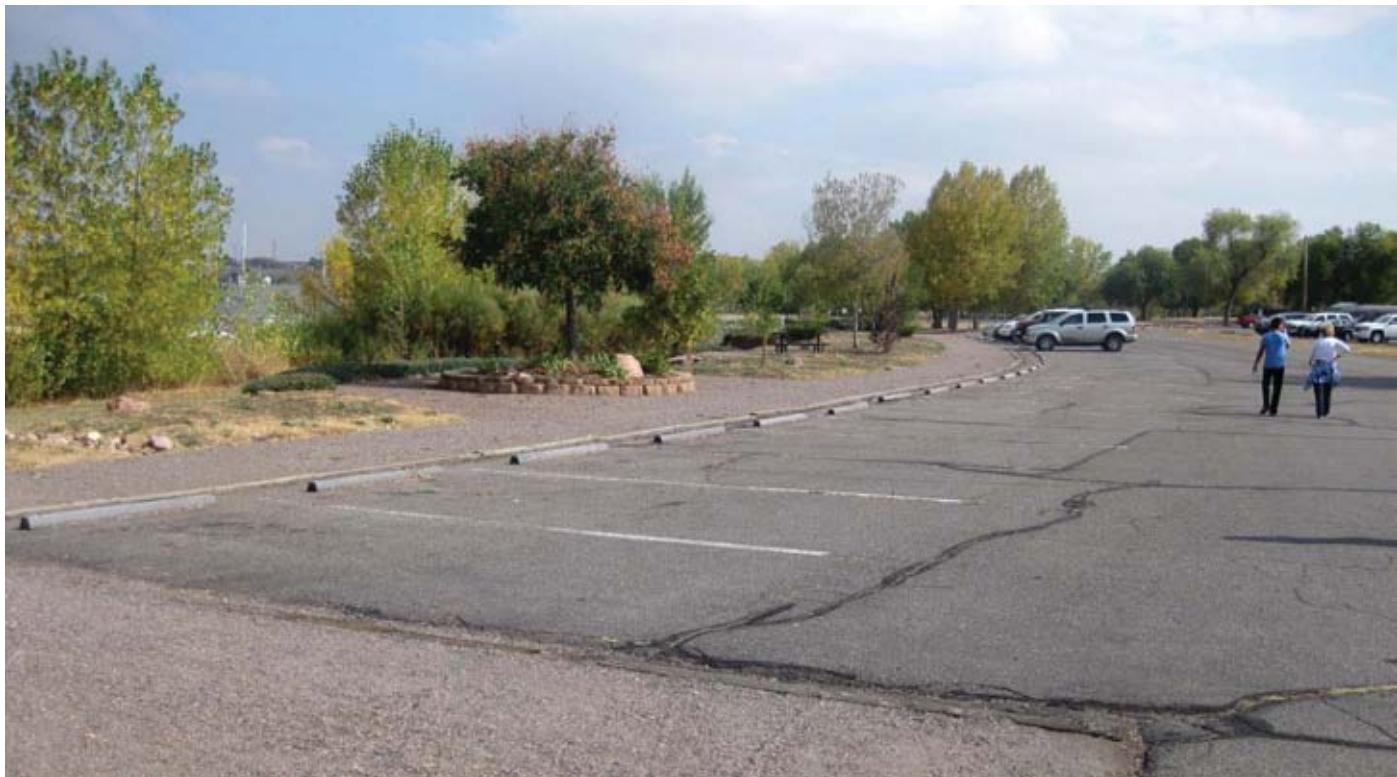
3-17 Existing Parking Lot

The marina facility is serviced by a 258 stall parking lot supplemented by a launch ramp parking facility with 65 trailer spaces and 62 car spaces. Both lots are contained within the bounds of the 5444'elevation affected zone. The lots are in fair condition.

The parking lots, roads and trails all require re-configuration to maintain usability throughout the range of water elevations associated with the reallocation. Removal of the paving material below the FWSP line is recommended. Additionally, consideration for moderate flooding conditions requires raising the grade of roadways and parking areas throughout the marina facility.

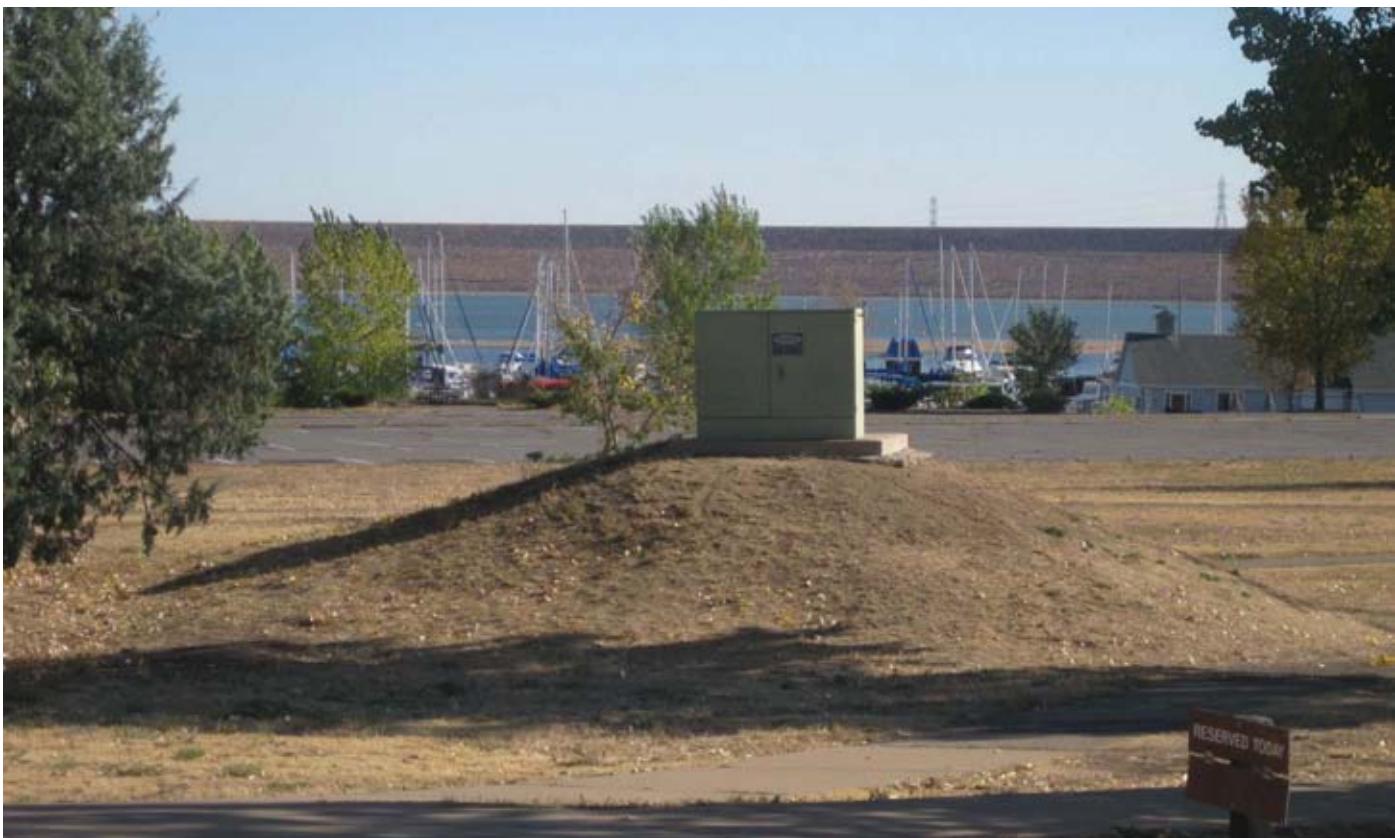
3-19 Primary Transformer

The electrical transmission lines throughout the park are buried. The primary transformer for the marina is located on an elevated mound south of the marina parking lot at approximate elevation 5,447' although the adjacent land is below the 5444' elevation. The electrical feed to the docks is hidden below the floating restaurant.

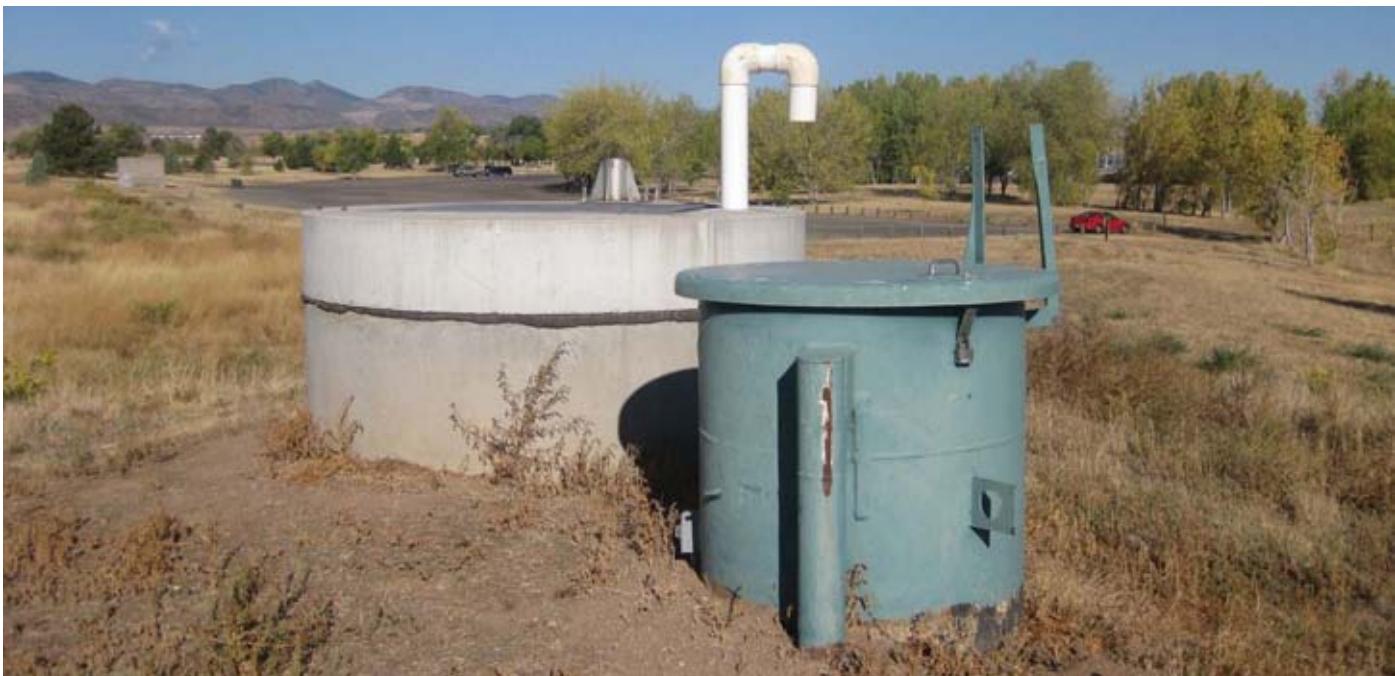
3-20 Lift Station 2

Marina waste is discharged via a lift station (FM1) from the restaurant building to the upland lift station approximately 1,700'; a second lift station (FM2) discharges the waste off site and into the municipal system another 4,700'. FM2 is located at 5,447' MSL and will be inundated during flood events.

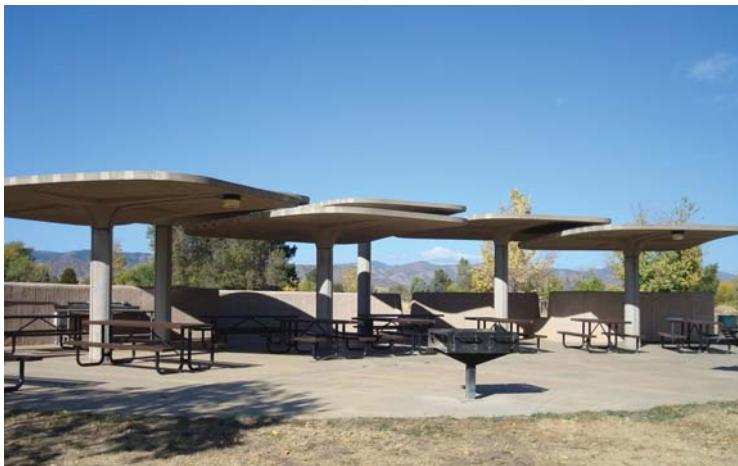
3-21 Picnic Shelter

Multiple shelters are located near the marina and seem to be well used. Previous flood events have caused catastrophic failures at some of the structures.

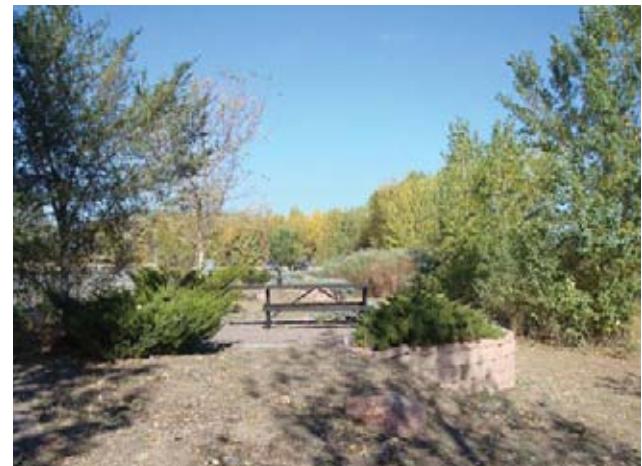
3-22 Picnic Table

Much of the park furnishings are dated and in only fair condition.
