Appendix HH
Comparative Review of Reservoir Fluctuation Zone
Chatfield Reallocation Project

**COMPARATIVE REVIEW OF
RESERVOIR FLUCTUATION ZONE
CHATFIELD REALLOCATION PROJECT**

U.S. Army Corps of Engineers,
Omaha District
1616 Capitol Avenue
Omaha, Nebraska 68102

November 29, 2012

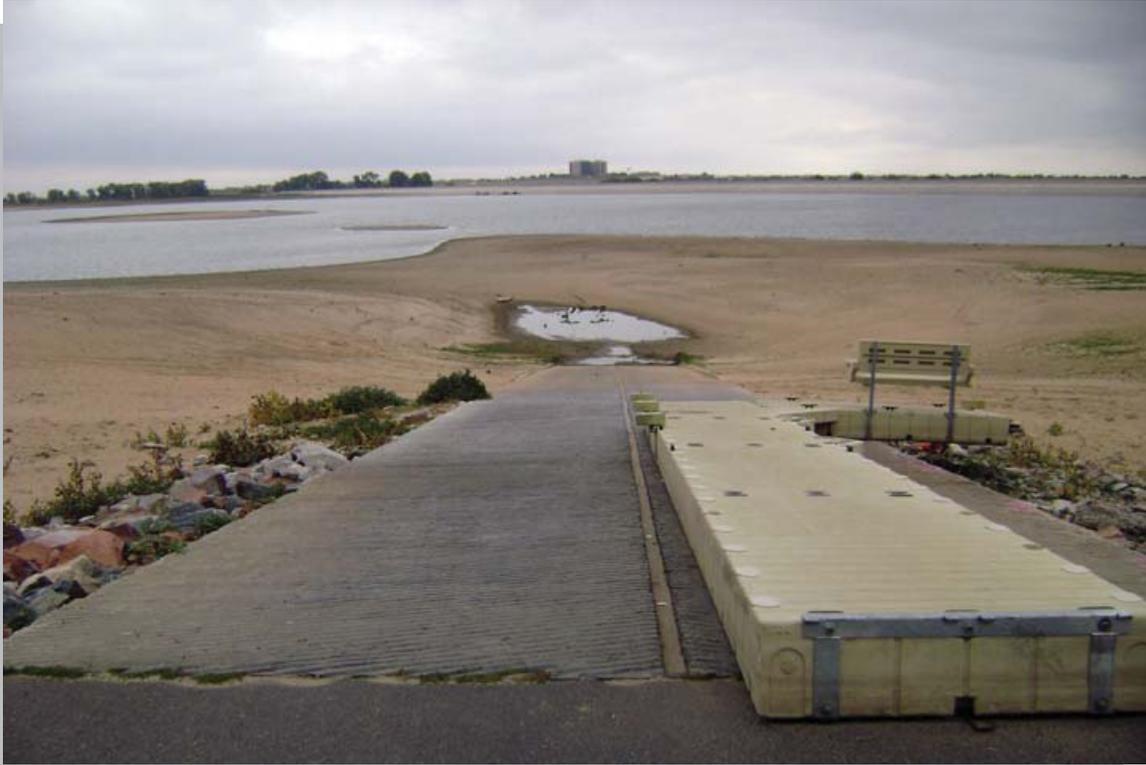
At the time of observation, the elevation of the water in Barr Lake was very low and portions of what is typically lake bottom were exposed (Photo 1). The soils of the fluctuation zone are comprised of sand. The only muddy areas observed were exposed lake bottom next to the open water.

Photo 1 - View of fluctuation zone from the boat ramp.

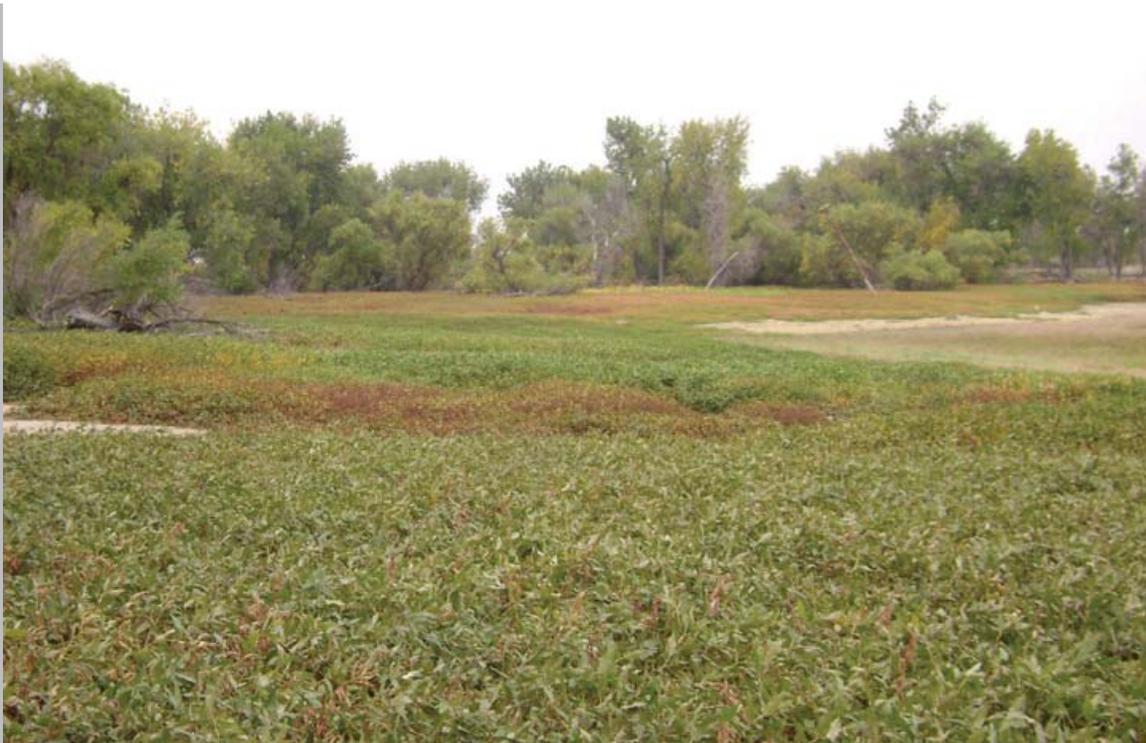
Barr Lake

Photo 2 - Dense growth of smartweed in upper portions of the fluctuation zone.

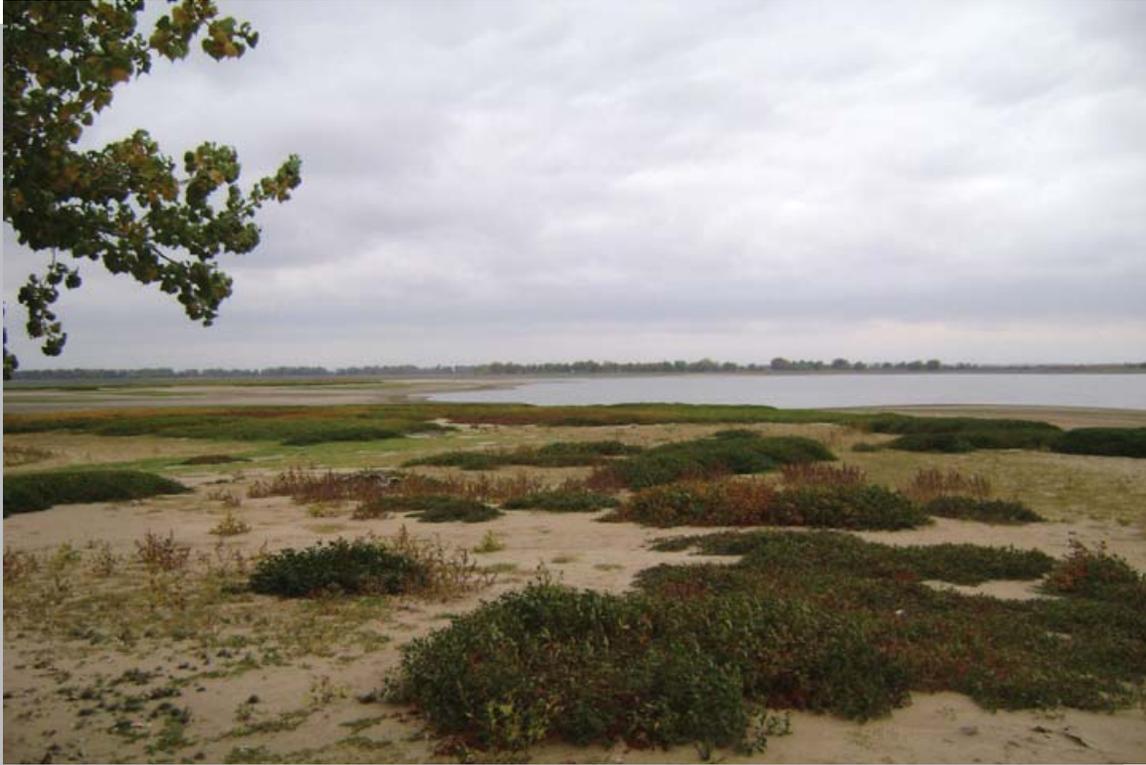
Barr Lake

Photo 3 - Clumps of smartweed with prostrate goosefoot growing between the clumps.

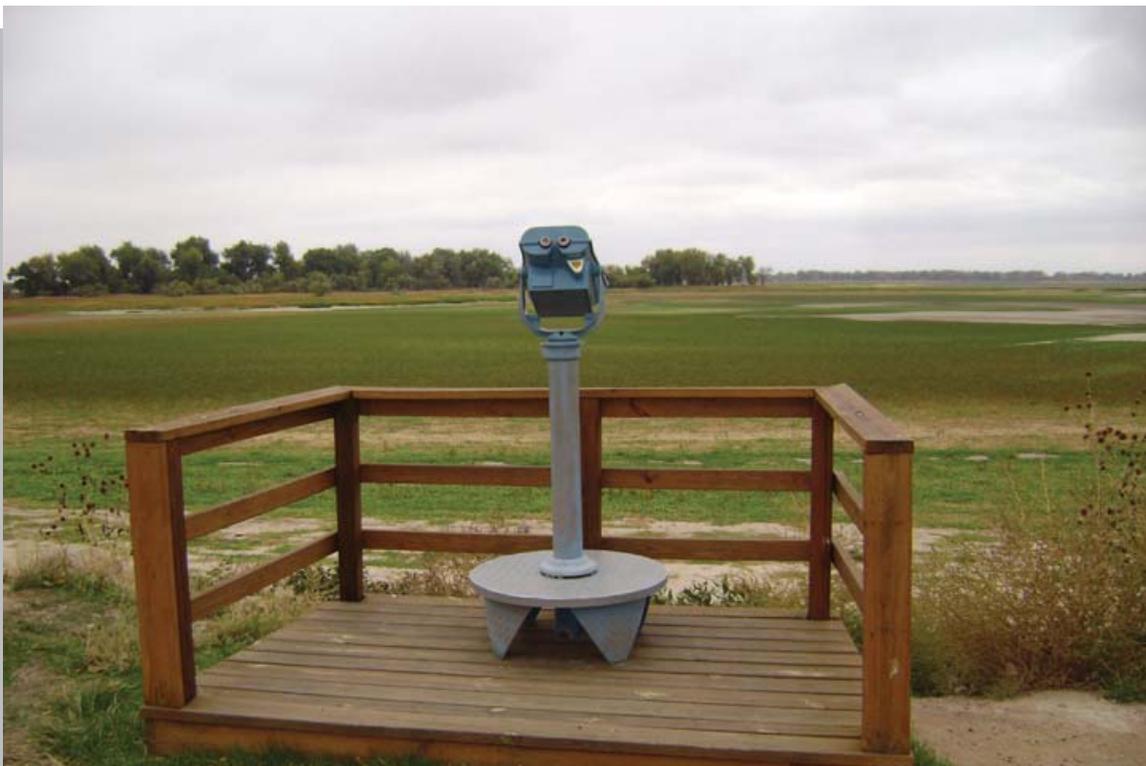
Barr Lake

Much of the upper portions of the fluctuation zone is vegetated with herbaceous species commonly associated with moist soils and drawdown areas. Smartweed (*Polygonum* spp.) and suckleya (*Suckleya suckleyana*) comprised most of the vegetation (Photos 2 and 3). The vegetation was generally low in stature. The suckleya had a prostrate growth form and the knotweed formed dense patches 1 to 2 feet tall. Cottonwoods along the shoreline showed obvious high water marks, indicating that the trees had been inundated for some period of time about 2 to 3 feet deep (Photo 4).

Photo 4 - Wildlife observation platform with views of vegetated portions of the fluctuation zone.

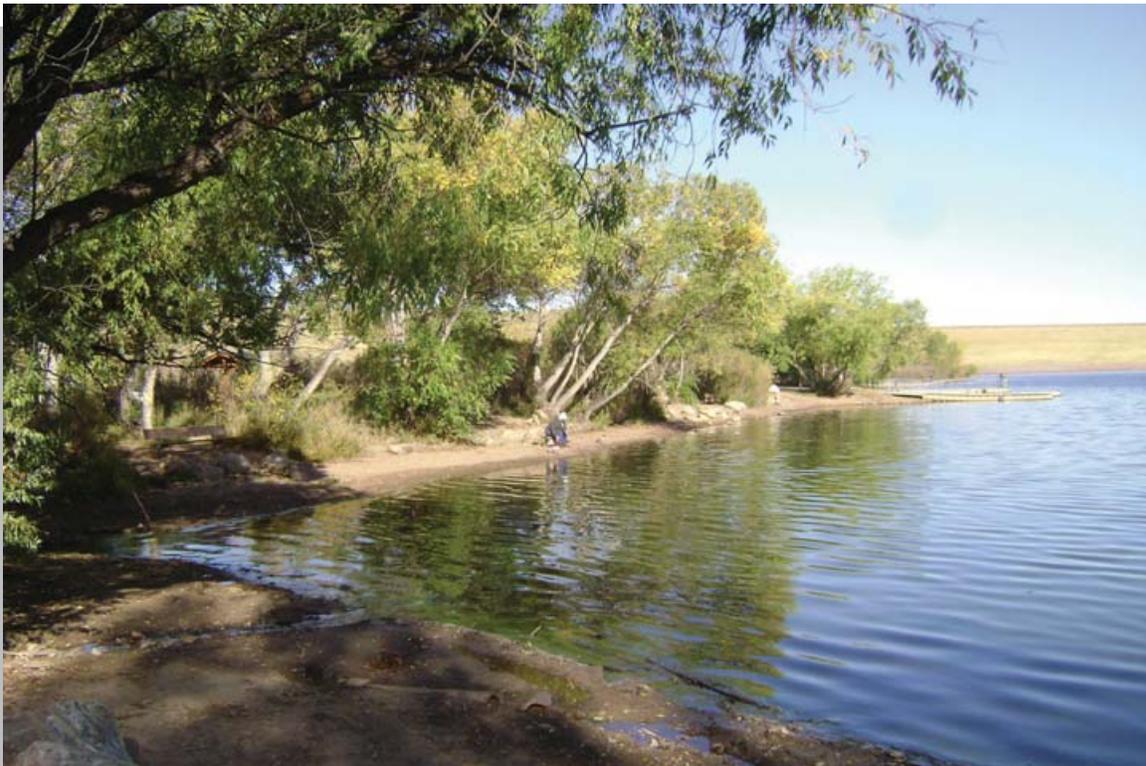
Bear Creek
Lake

At the time of the on-site review, the exposed fluctuation zone was about 10 feet wide in most locations (Photo 6). The fluctuation zone substrate is comprised of sand. No mudflats were observed. There are some fines where Bear Creek and Turkey Creek flow into the reservoir (Photo 8).

Photo 6 - Typical shoreline at Bear Creek Lake.

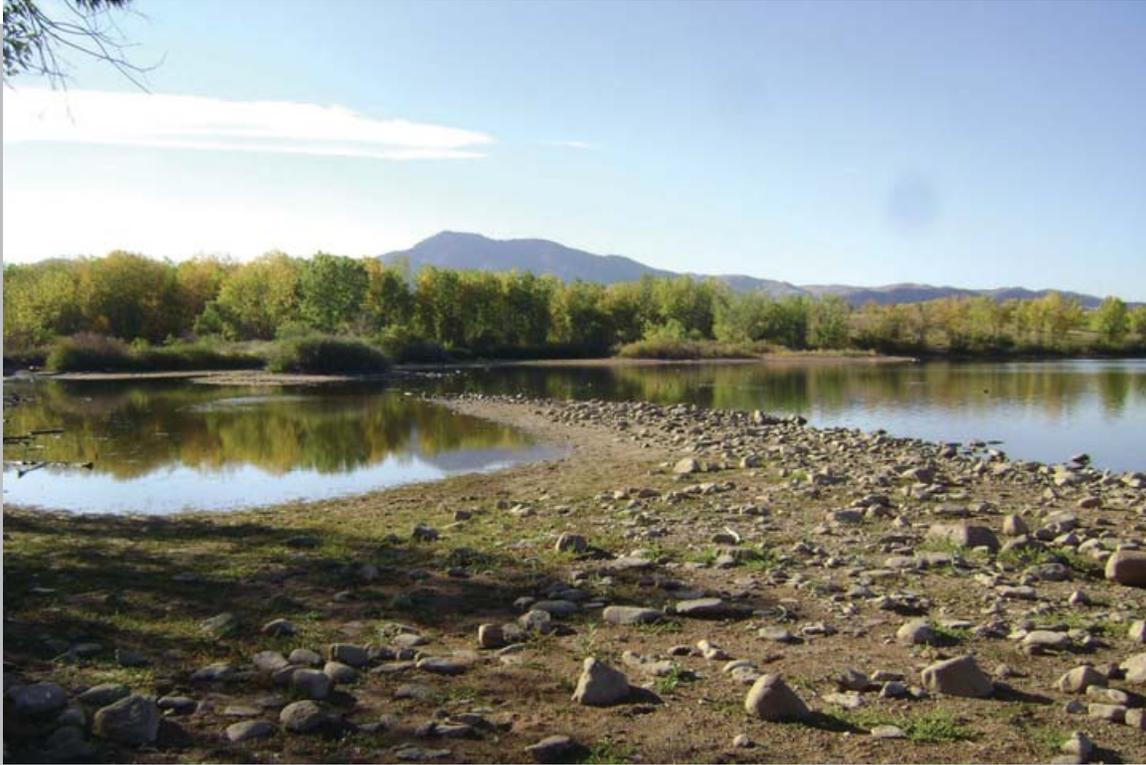
Bear Creek
Lake

Minimal vegetation was observed within the fluctuation zone. Scattered individuals of knotweed and goosefoot were observed (Photo 7).

Photo 7 - Exposed portion of Bear Creek Lake.

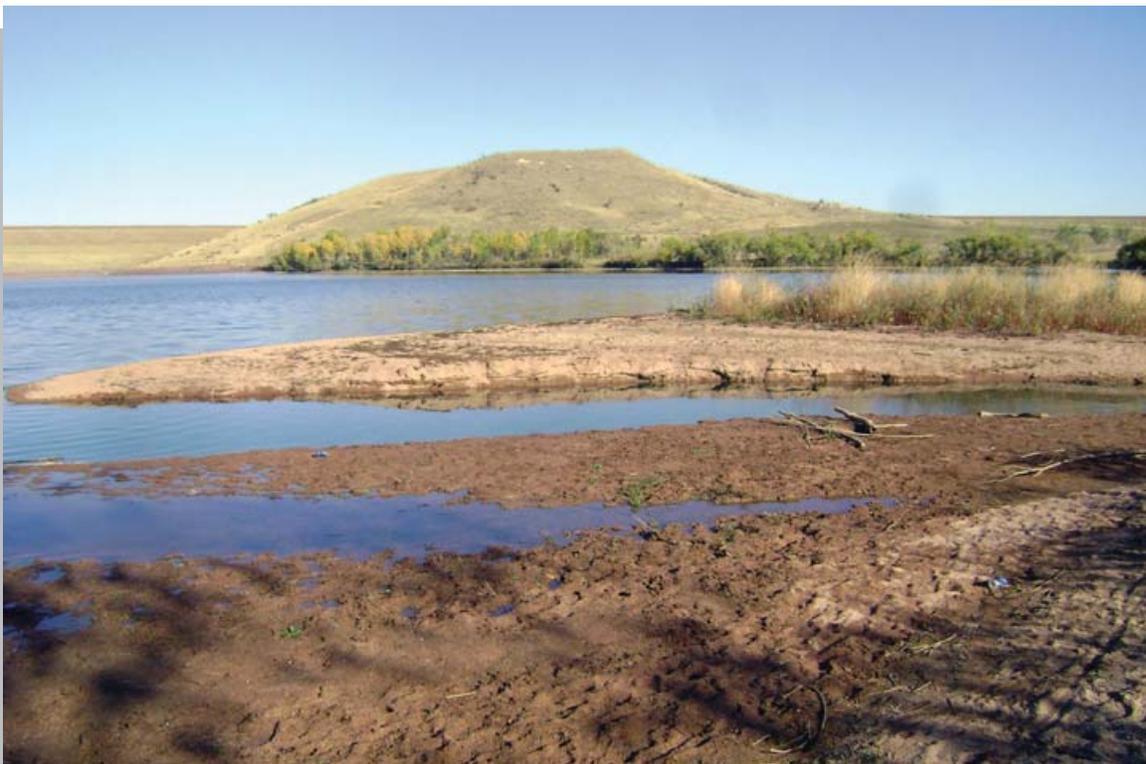
Bear Creek
Lake

Photo 8 - Exposed substrate and some muddy areas at the Turkey Creek delta area.

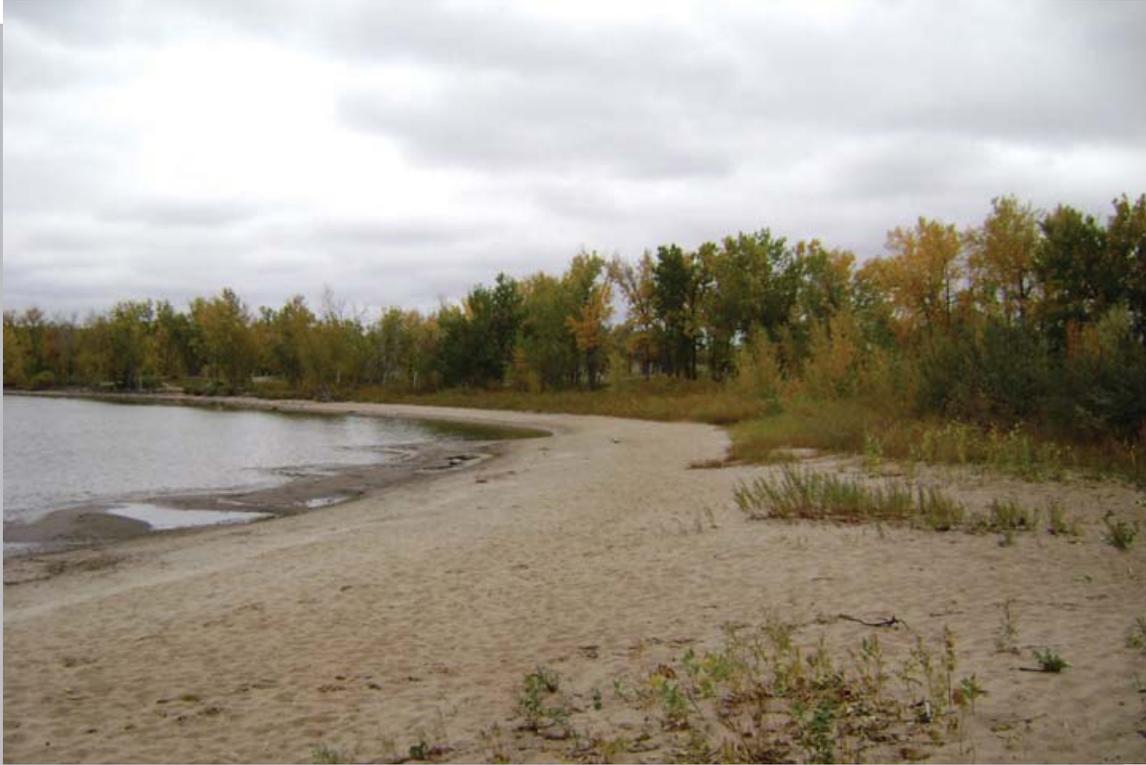
Cherry Creek
Reservoir

Photo 9 - Typical shoreline at Cherry Creek Reservoir.

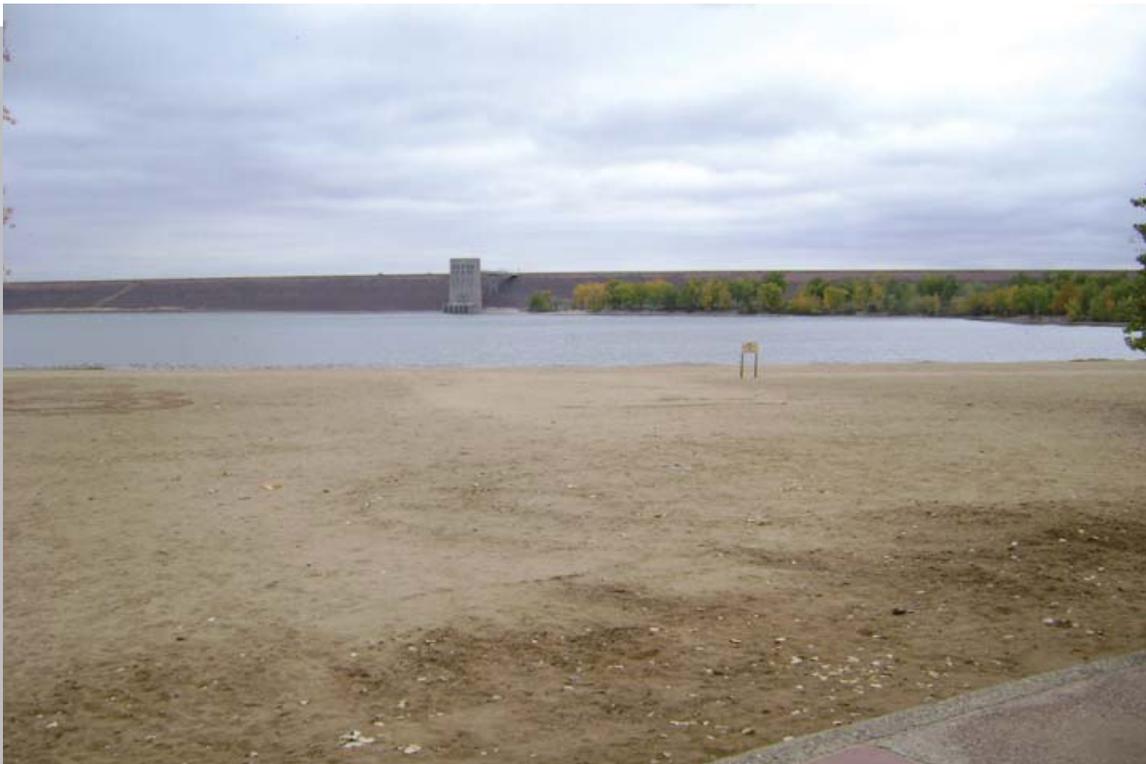
Cherry Creek
Reservoir

The exposed reservoir shoreline along much of the reservoir was about 40 to 50 feet wide and estimated to be about 4 to 5 feet below the OHWM. The distance between the bathrooms/change facilities and the edge of the water at the swim beach was about 380 feet at the time of the site review (Photo 10).

Photo 10 - Swim beach with facilities patio in the foreground.

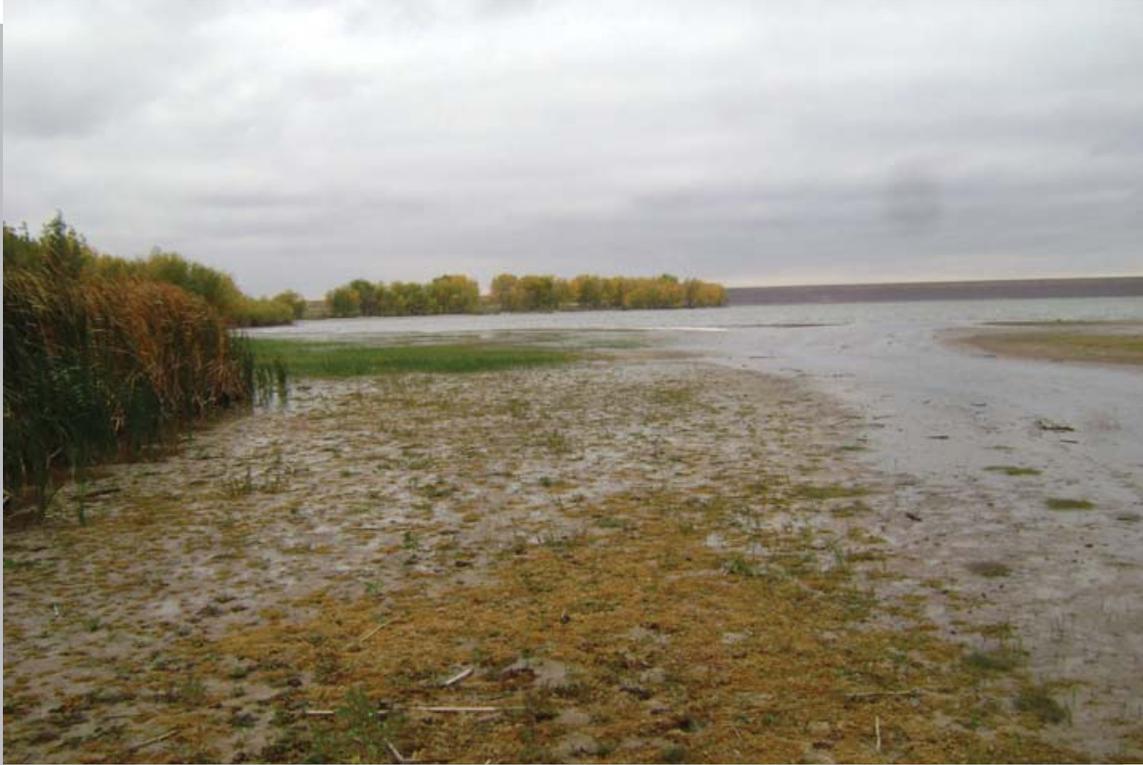
The fluctuation zone substrate is comprised of sand, the only observed mudflat occurred on the delta formed where Cottonwood Creek flows into the reservoir (Photo 11). Cottonwood

Creek drains the plains region of Arapahoe and Douglas counties and transports clay and silt sized materials to Cherry Creek Reservoir to form the mudflat delta.

Photo 11 - Mudflat and wetland at the Cottonwood Creek delta.

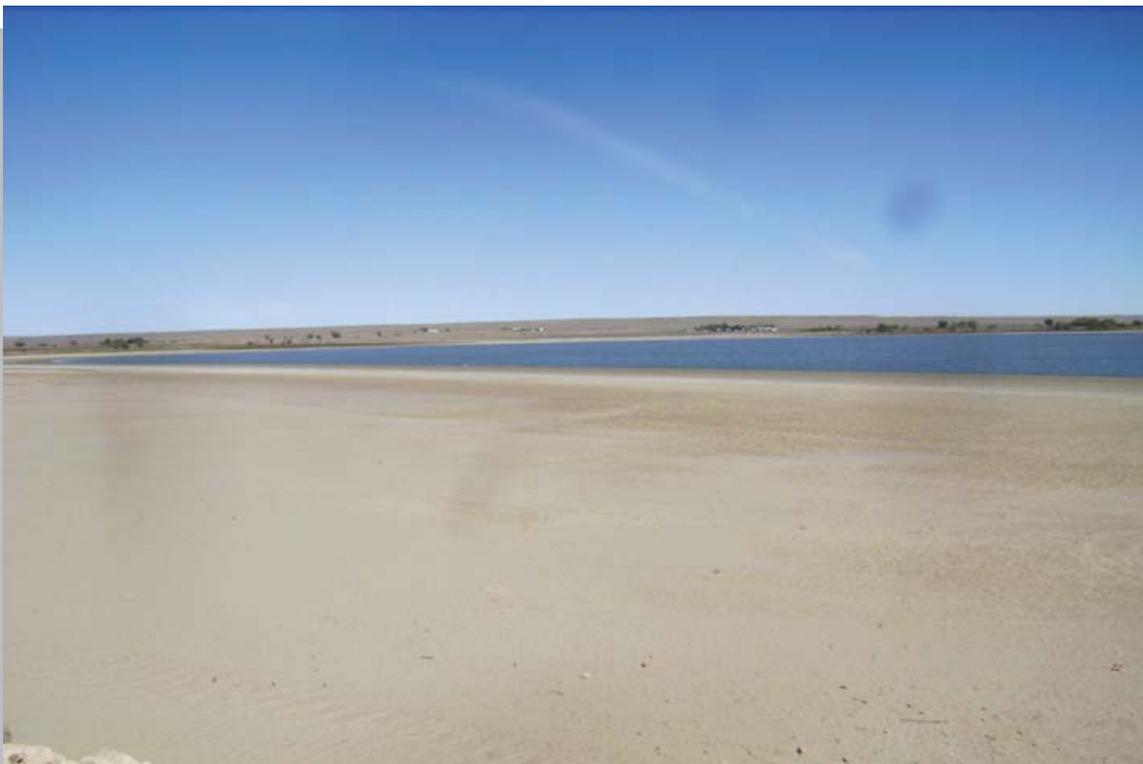
Jackson
Reservoir

The fluctuation zone substrate is comprised of sand. At the time of the site review, reservoir water levels had declined substantially, exposing a portion of the reservoir bottom where organics and fines have accumulated. The exposed bottom formed a narrow muddy border around the water's edge (Photo 13). The soils in this area were soft and muddy, but would support travel. Except for this narrow exposed area of reservoir bottom, the fluctuation zone was a sandy beach and not a mudflat (Photo 12).

Photo 12 - Overview of fluctuation zone with very little vegetation.

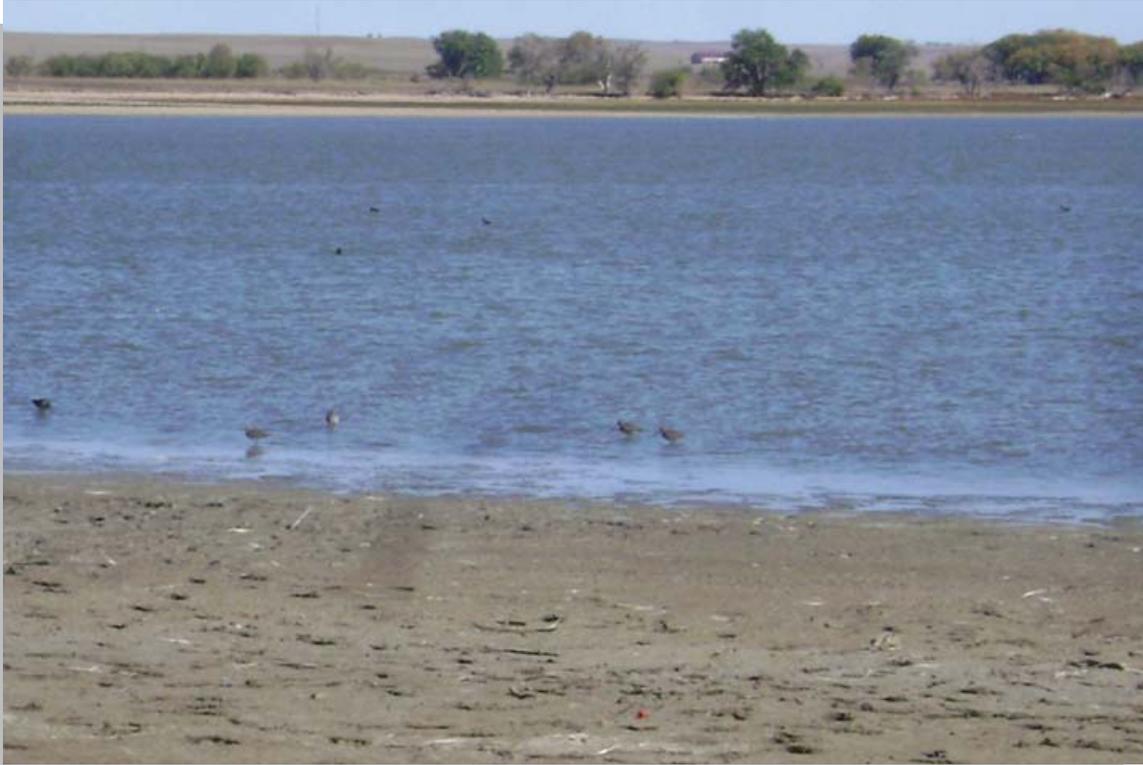
Jackson
Reservoir

Photo 13 - Exposed muddy reservoir bottom next to open water and shorebirds.

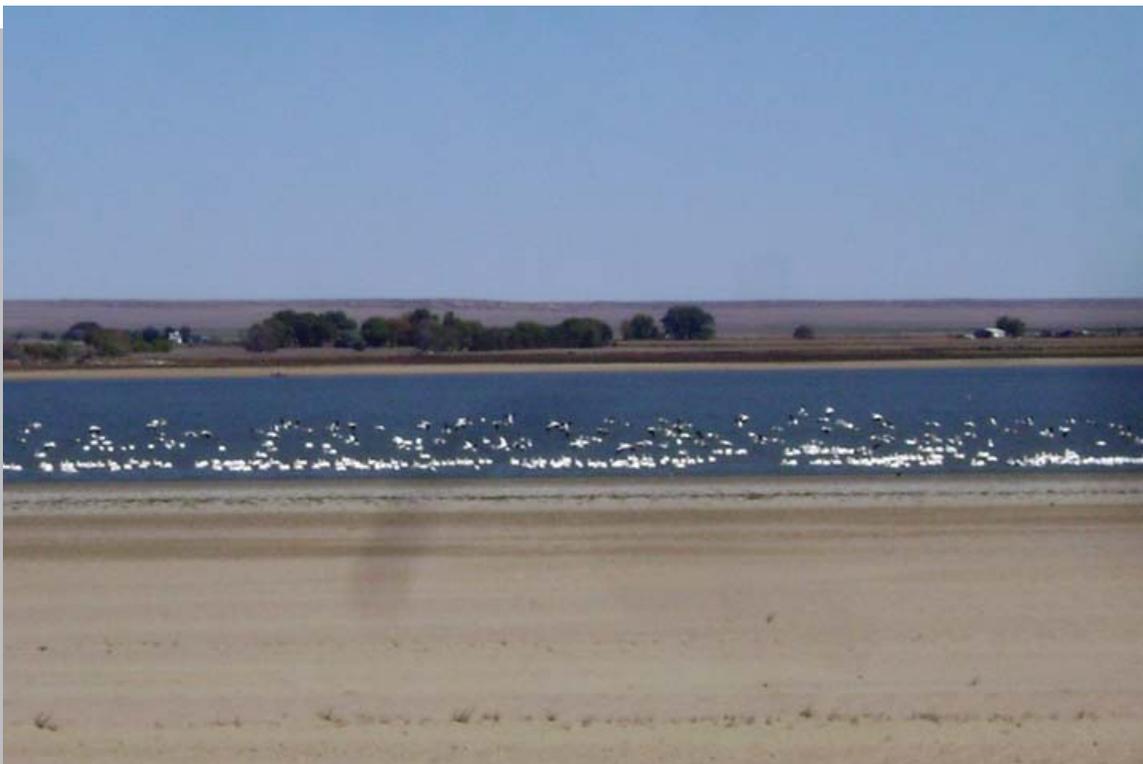
Jackson
Reservoir

Photo 14 - Snow geese along the reservoir shoreline.

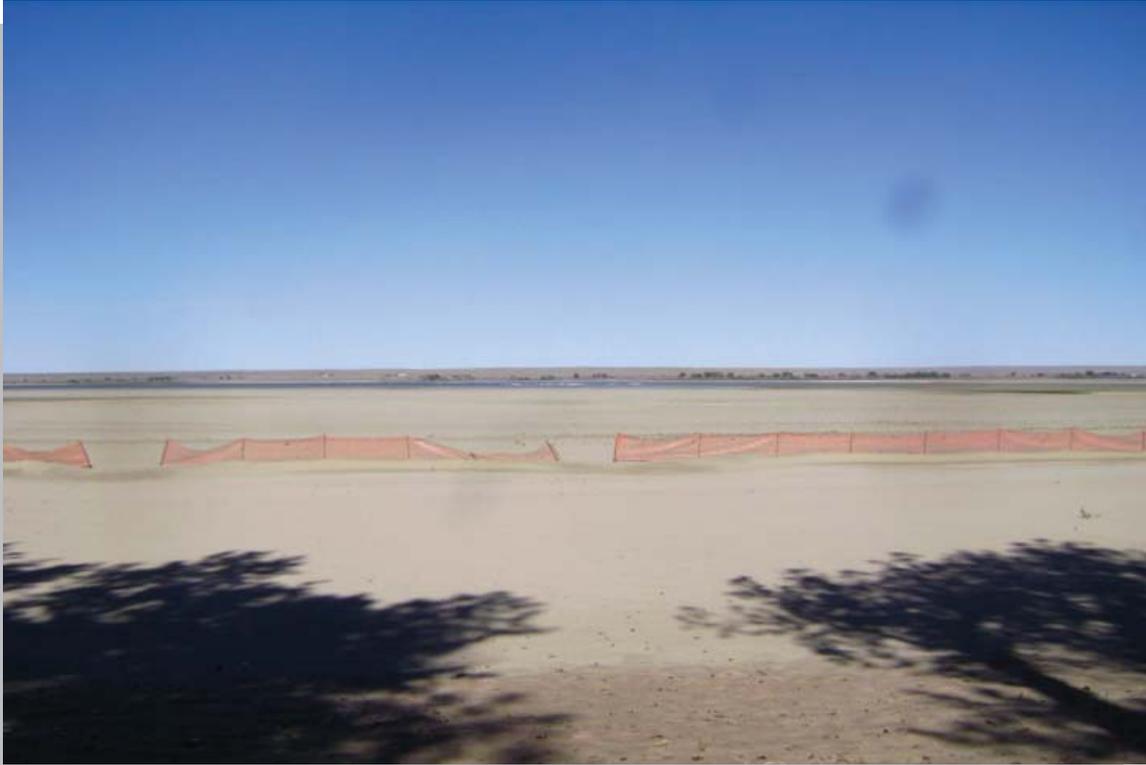
Jackson
Reservoir

The exposed reservoir shoreline was extensive at the time of the site review. The reservoir is valued for its abundant wildlife and bird watching opportunities (CSP 2010b). At the time of the site review, numerous shore birds and hundreds of snow geese were using the reservoir (Photo 14). Jackson Lake State Park is ranked one of the "Top 15 Park Beaches" by a national camping service (CSP 2010b). At the time of the site review, the walk from the change rooms and bathrooms was about 615 feet to the swim beach and about 280 feet from the swim beach to the nearest porta-potty (Photo 15).

Photo 15 - Swim beach.

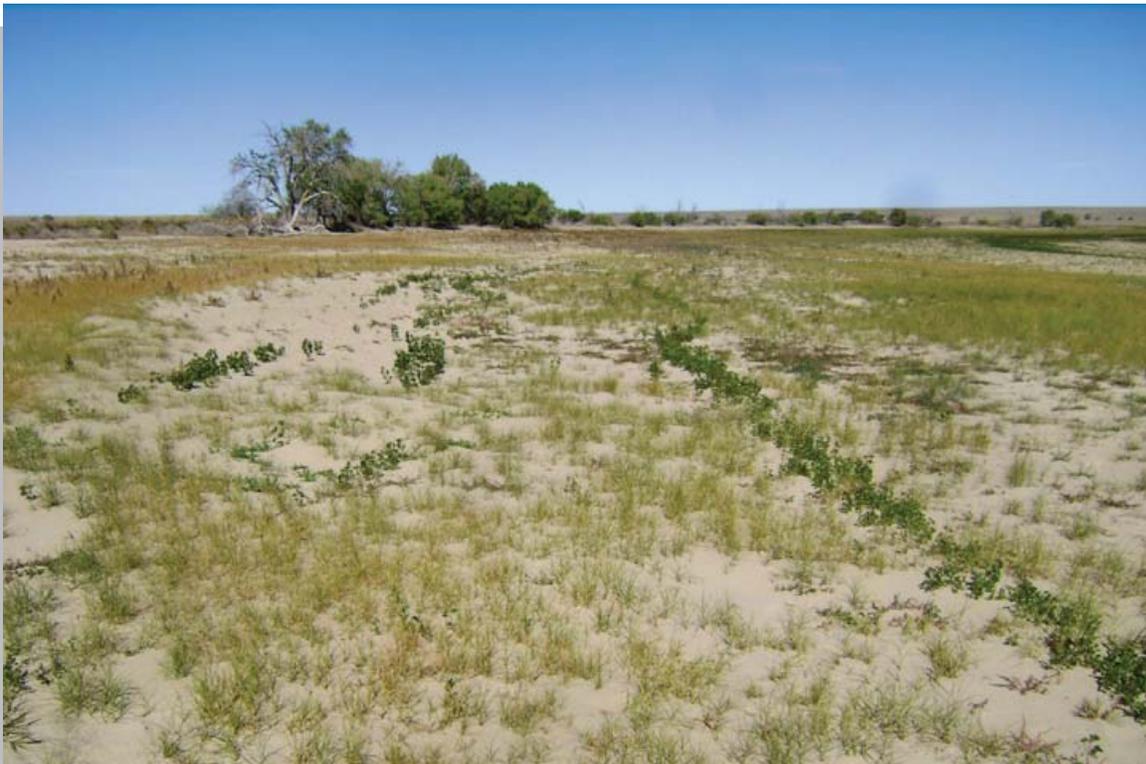
Jackson
Reservoir

Portions of the fluctuation zone were vegetated (Photo 16). All of the vegetation appeared to have become established during the 2012 growing season. Commonly occurring vegetation includes knotweed, goosefoot, three-square (*Schoenoplectus pungens*), and barnyard grass (*Echinochloa crus-galli*). Additionally, numerous cottonwood seedlings form concentric rings in portions of the fluctuation zone, similar to what is described above for salt cedar.

Photo 16 - Vegetation within the fluctuation zone. Threesquare mixed with rows of plains cottonwood seedlings.

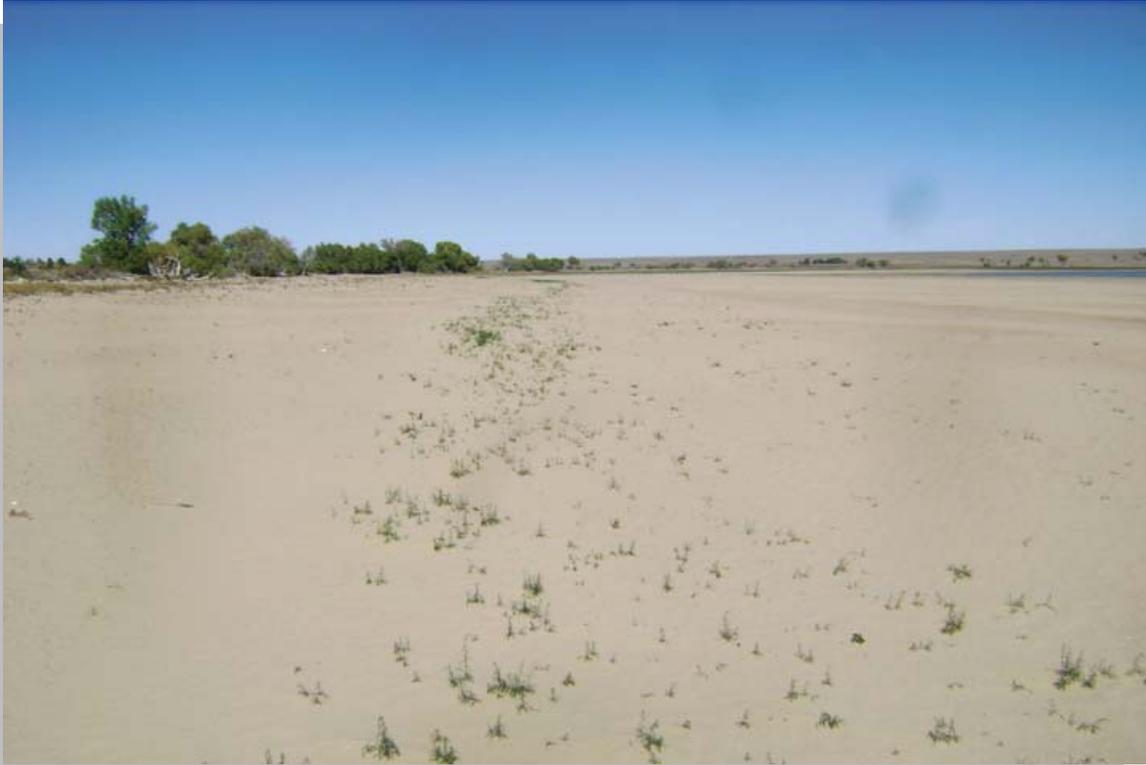
Jackson
Reservoir

Vegetation, including noxious weeds, has established in portions of the fluctuation zone. Salt cedar (*Tamarisk ramosissima*) seedlings occurred in concentric rings within portions of the fluctuation zone (Photo 17). Salt cedar is a State "B List" species, which has been designated for control to stop its continued spread. Although hundreds of salt cedar seedlings were observed, no mature salt cedars were observed. Salt cedar is likely controlled by CDPW, as CDPW has noted that control of noxious weeds is one of the challenges faced by park management (CSP 2010b). Cocklebur also occurred in scattered patches within the fluctuation zone (Photo 18).

Photo 17 - A row of salt cedar seedlings.

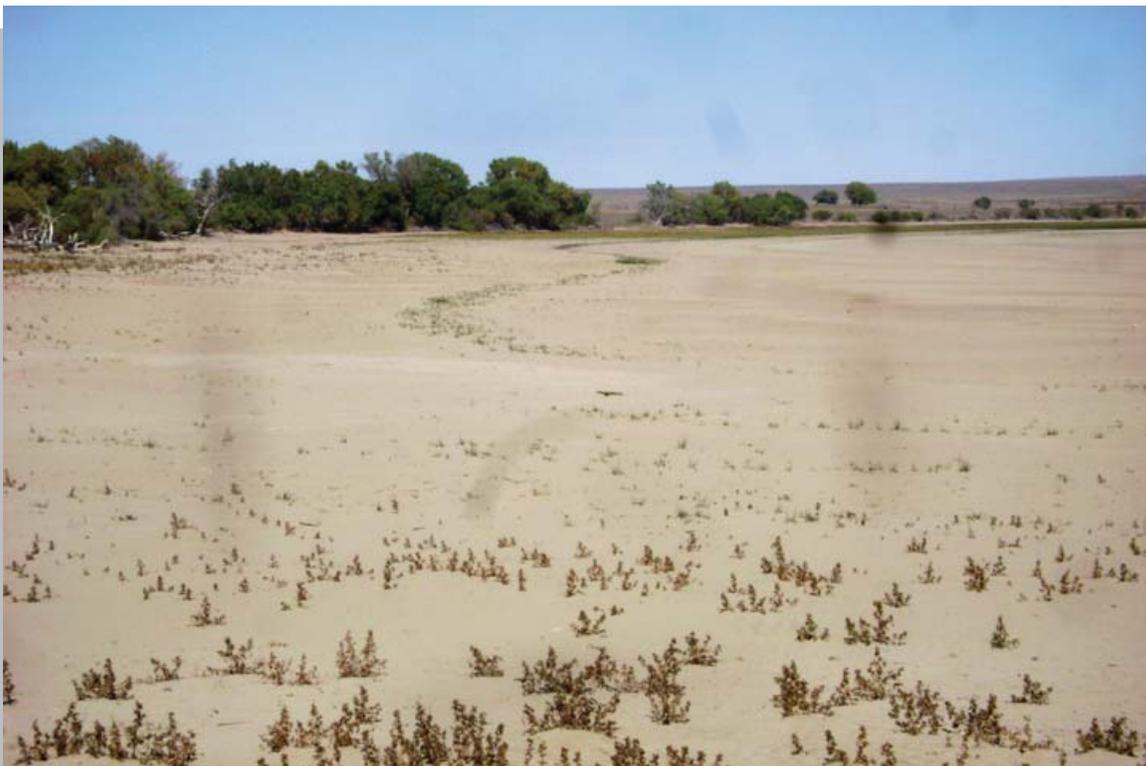
Jackson
Reservoir

Photo 18 - Scattered cockleburrs in the foreground with salt cedar row in the background.

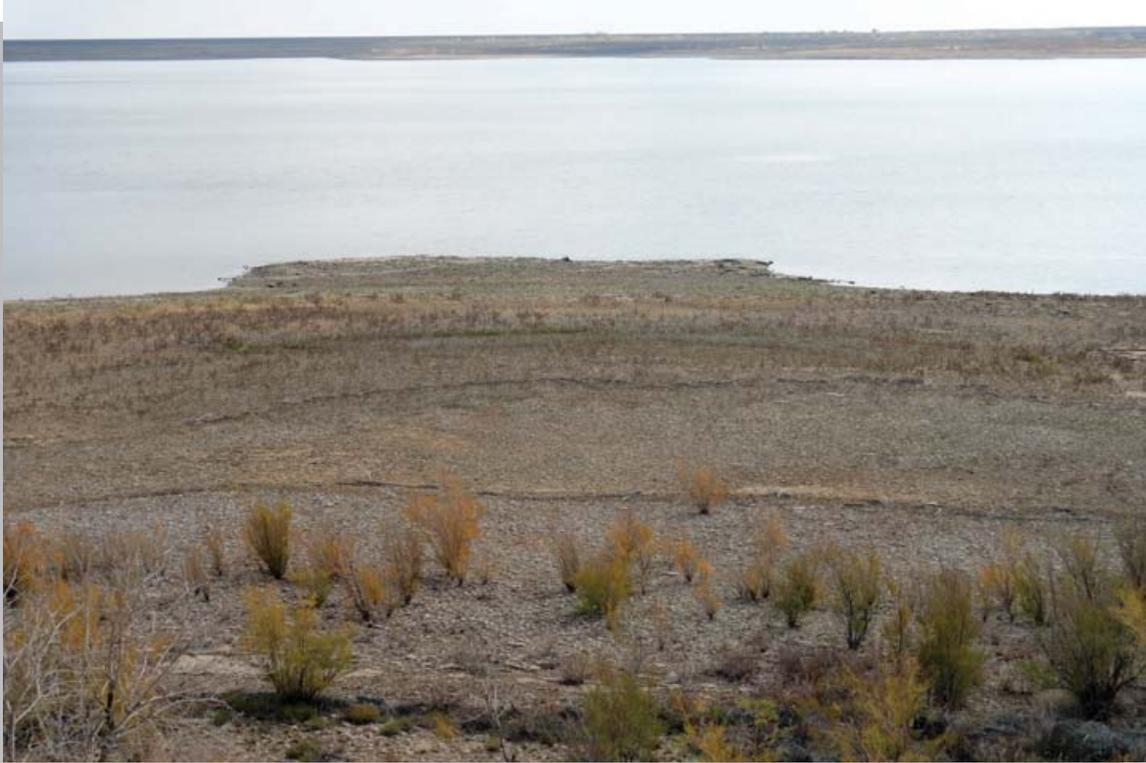
John Martin
Reservoir

Photo 19 - Overview of the fluctuation zone.

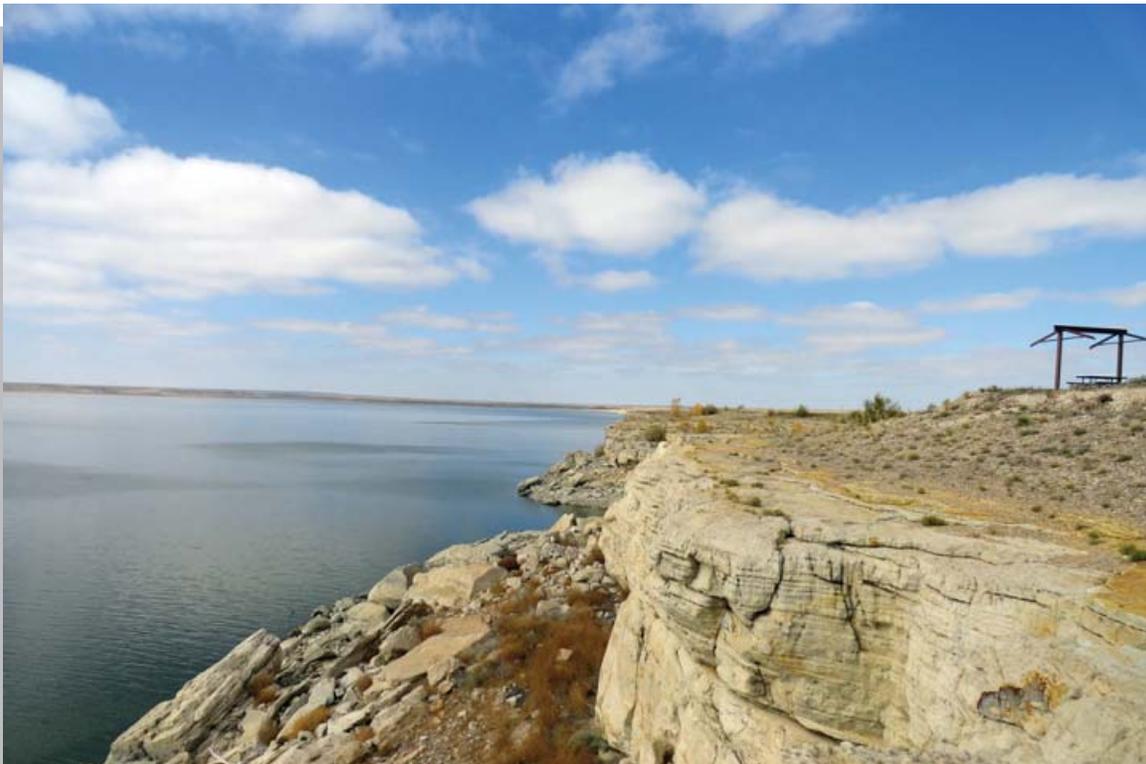
Dakota sandstone outcrops and cliffs border the reservoir (Photo 20). The fluctuation zone substrate is comprised of sand, broken sandstone, and cobble associated with the Arkansas River alluvium. Similar to Pueblo Reservoir, the upper ends of inlets at John Martin Reservoir have a finer substrate. Only one muddy area was observed within the state park and it occurred at the margin of the shoreline adjacent to the water's edge (Photo 22). This area supported a wetland with saturated soils.

Photo 20 - Much of the reservoir is bordered by steep sandstone cliffs.

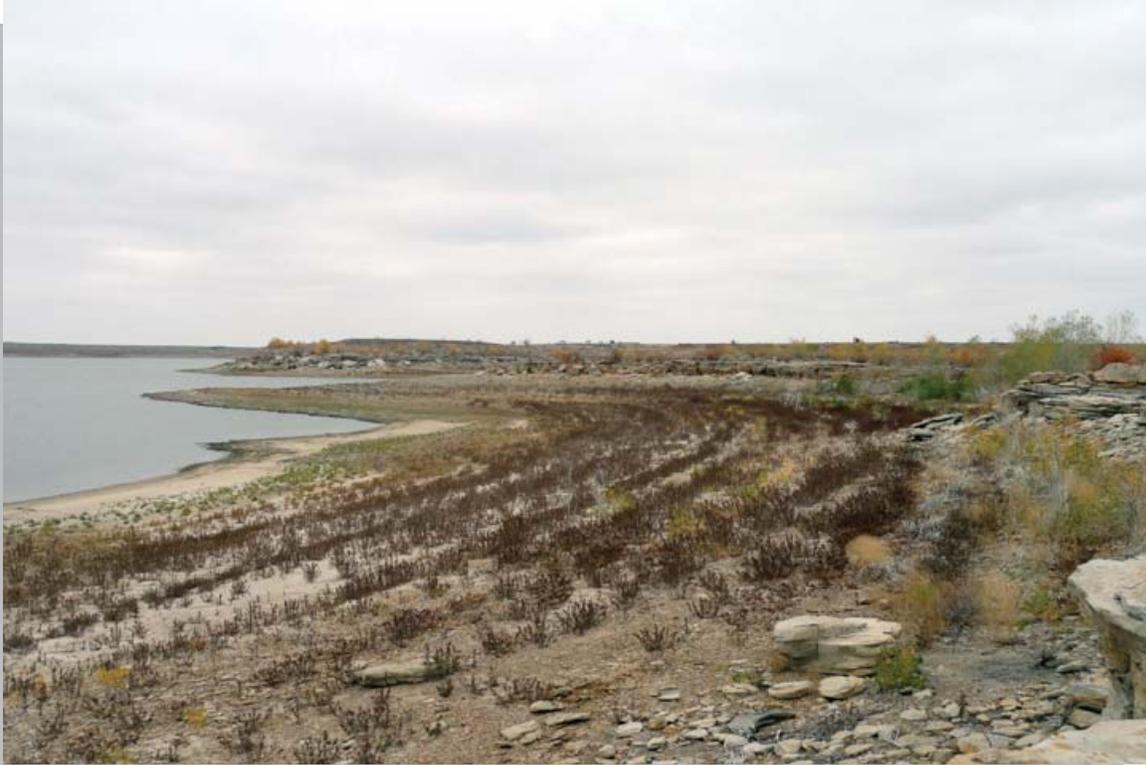
Similar to Pueblo Reservoir, the inlets of John Martin Reservoir support vegetation within the fluctuation zone, including weeds. Cocklebur and salt cedar were commonly observed within the fluctuation zone within inlets (Photo 21). Of the reservoirs reviewed for this study, John Martin Reservoir was the only reservoir where mature salt cedar was commonly observed (Photo 23).

Photo 21 - Cockleburs form concentric rings along the shoreline of an inlet.

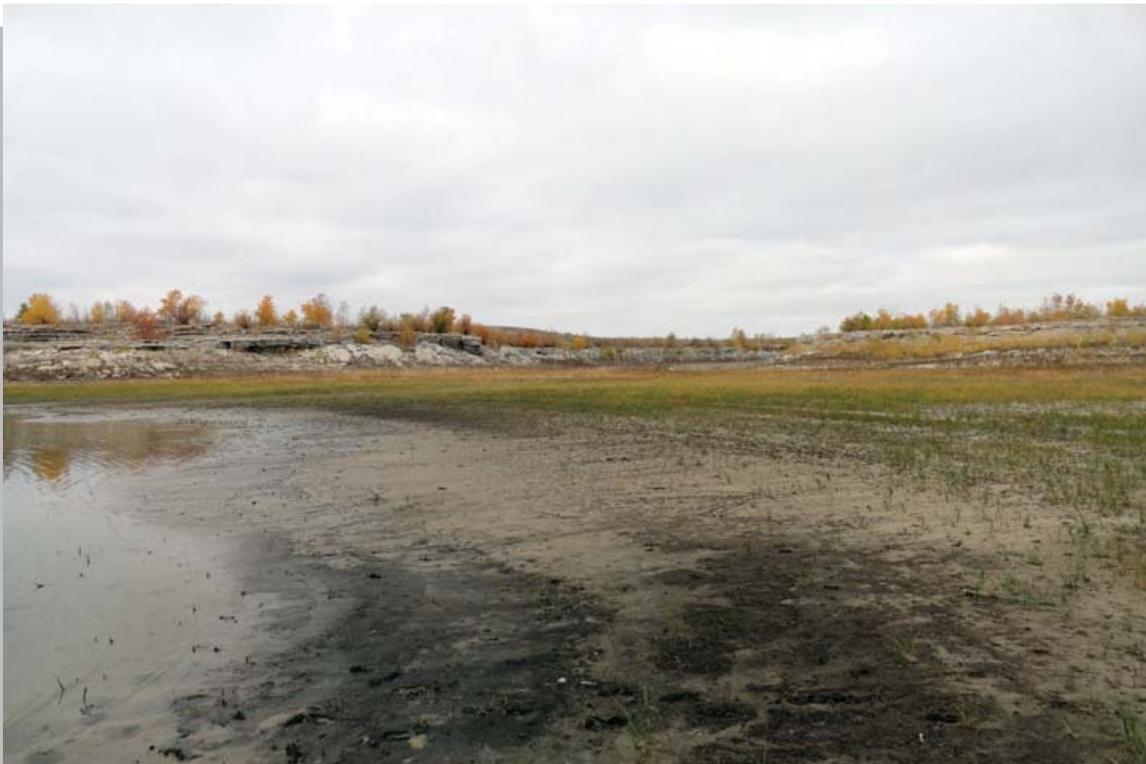
John Martin
Reservoir

Photo 22 - Mudflat and wetland at the head of an inlet.

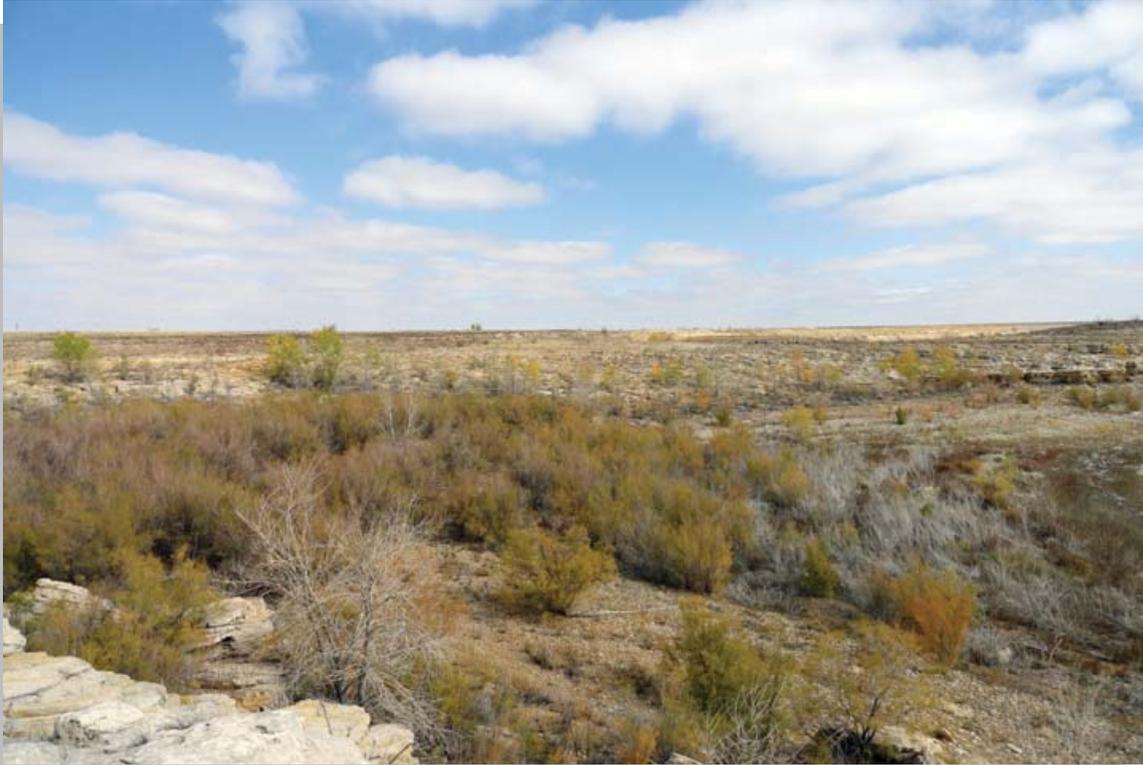
John Martin
Reservoir

Photo 23 - Mature salt cedar at higher elevations of the fluctuation zone.

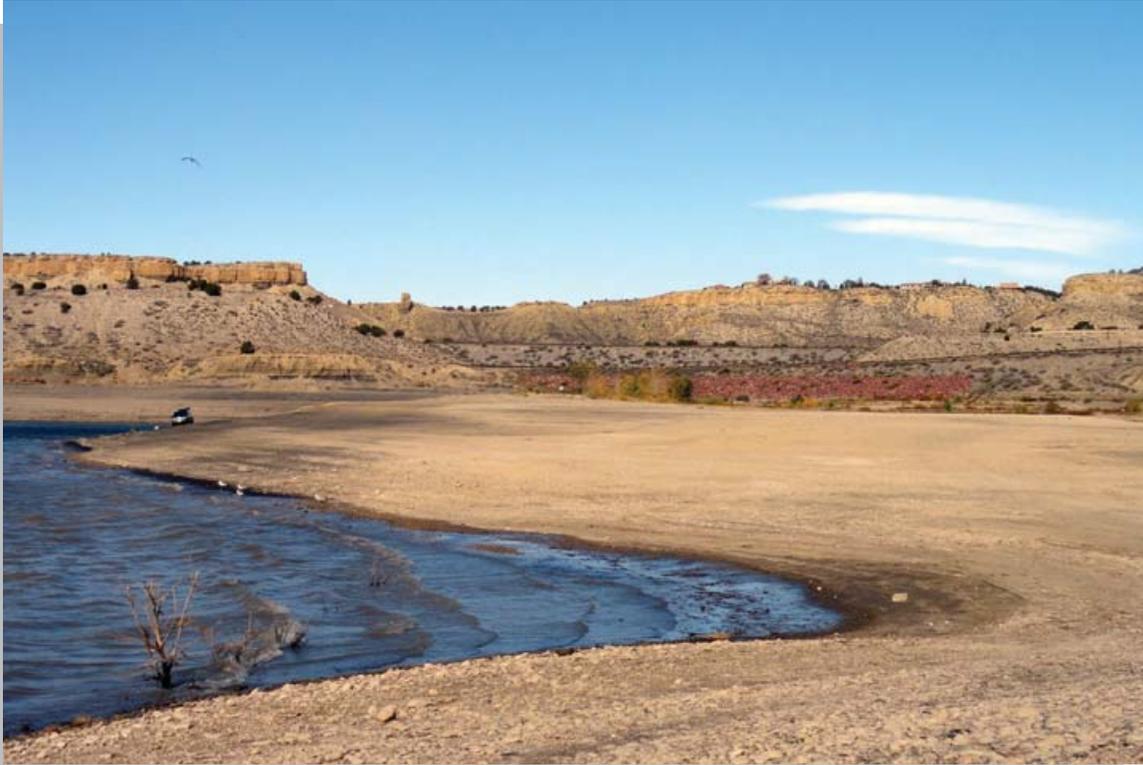
Pueblo
Reservoir

Photo 25 - Overview of the fluctuation zone.

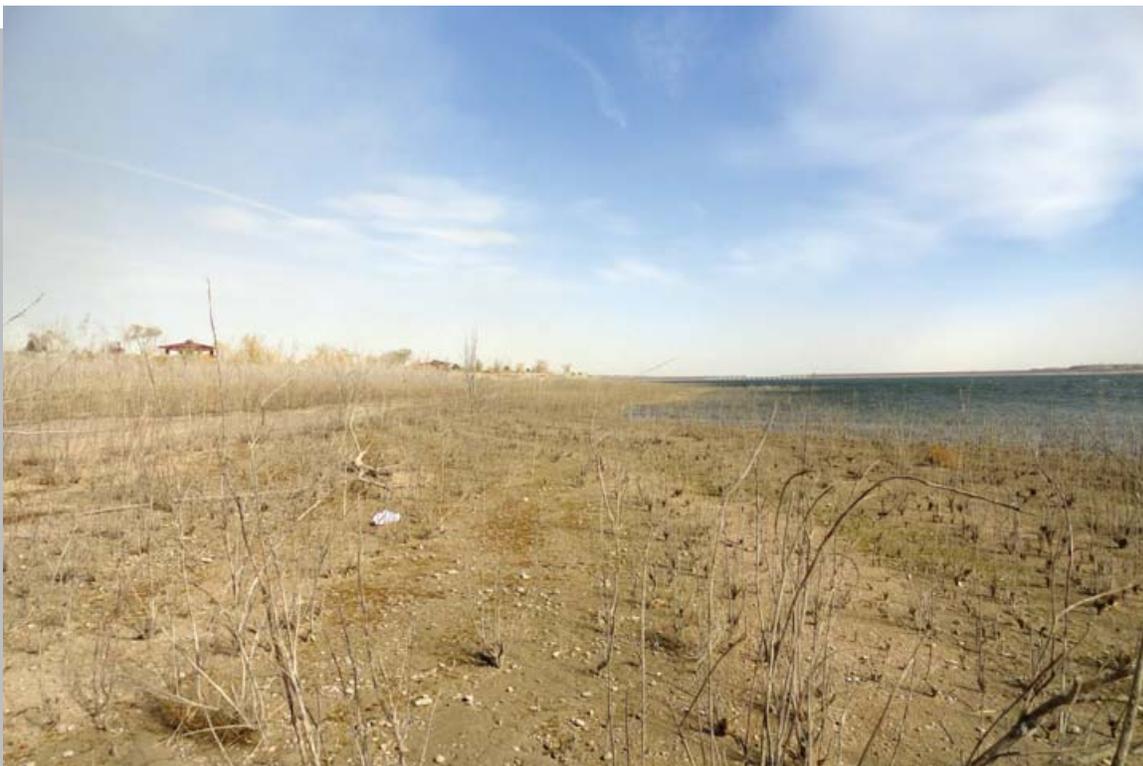
Most of the Pueblo Reservoir shoreline is unvegetated. As discussed above, the inlet portion of the fluctuation zone supports vegetation. In addition to the weeds discussed above, vegetation in these areas also include annual sunflower (*Helianthus annuus*), coyote willow, curly cup gumweed (*Grindelia squarrosa*), plains cottonwood, and witchgrass (Photo 27). Water levels in Pueblo Reservoir fluctuates greatly. At the time of the site review, water levels were an estimated 20 to 25 feet below the reservoir's high-water elevation. Cottonwoods and willows appear to become established within the fluctuation zone during periods of prolonged drawdowns and are subsequently inundated and killed during higher water levels (Photo 26). The cycle appears to repeat periodically.

Photo 26 - Cottonwoods and willows established at lower water levels and subsequently inundated.
