Appendix HH
Comparative Review of Reservoir Fluctuation Zone
Chatfield Reallocation Project

**COMPARATIVE REVIEW OF
RESERVOIR FLUCTUATION ZONE
CHATFIELD REALLOCATION PROJECT**

U.S. Army Corps of Engineers,
Omaha District
1616 Capitol Avenue
Omaha, Nebraska 68102

November 29, 2012

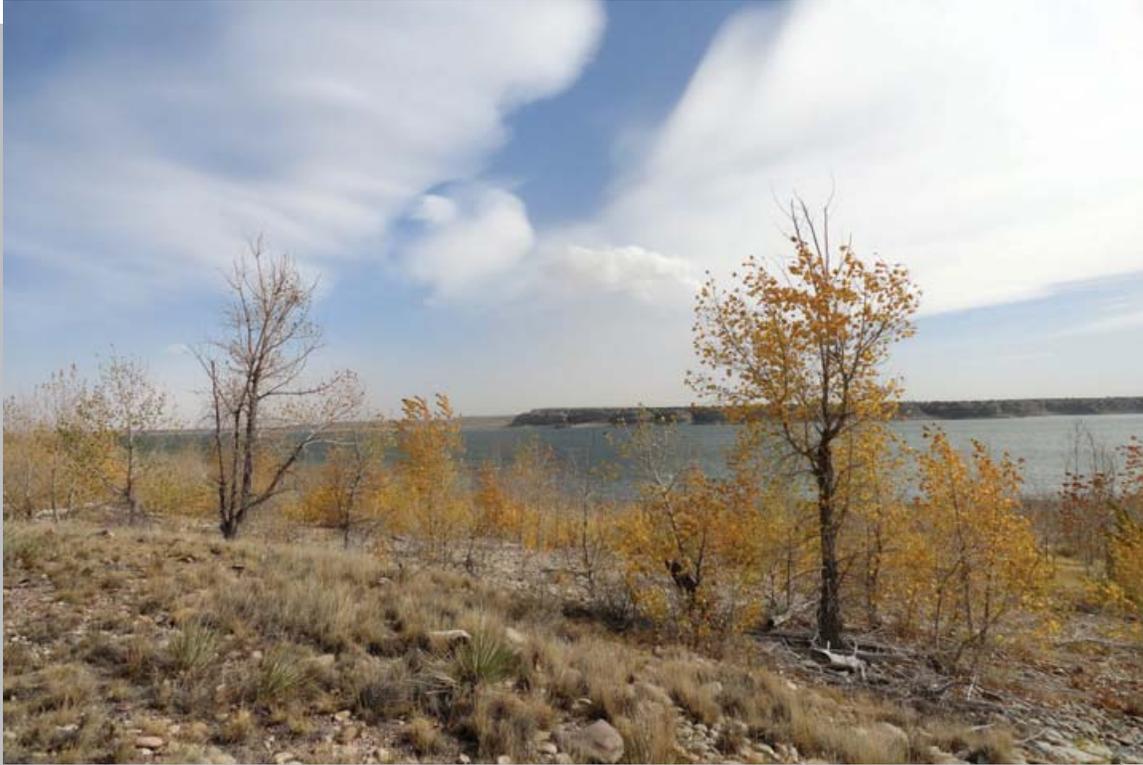
Pueblo
Reservoir

Photo 27 - Cottonwoods established at the upper portion of the fluctuation zone.

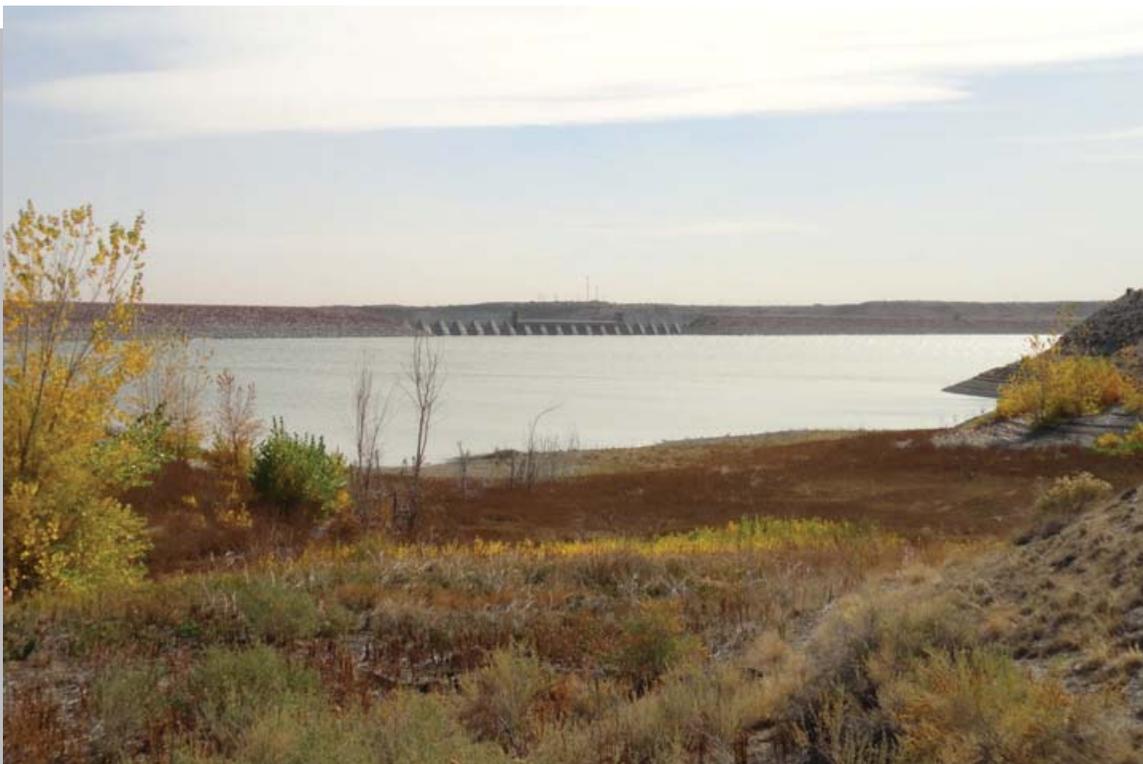
Pueblo
Reservoir

Weeds were observed in the scattered inlet portions of the fluctuation zone (Photos 28, 29, and 30). Some salt cedar seedlings were observed within these areas, as well as more mature individual salt cedars scattered around the reservoir above the OHWM. Cocklebur commonly occurred in the inlet portions of the fluctuation zone.

Photo 28 - Cocklebur (rust brown color) within the fluctuation zone of an inlet.

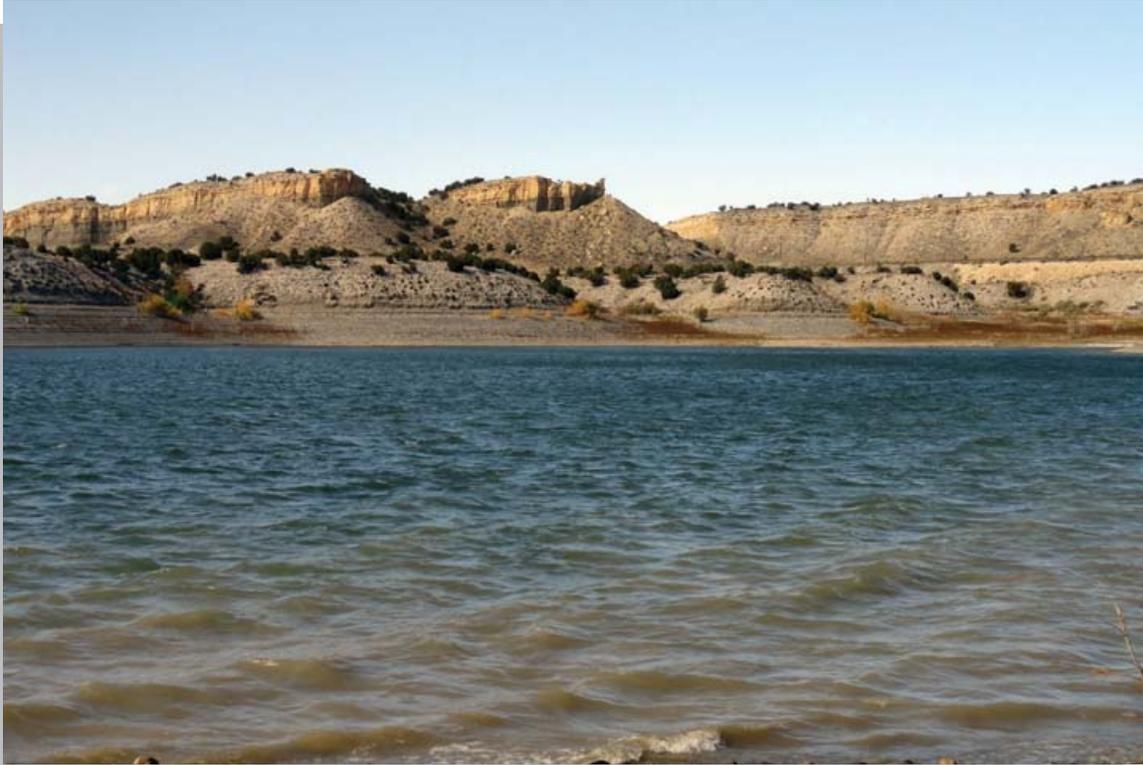
Pueblo
Reservoir

Photo 29 - Overview of fluctuation zone. Background shows how vegetation is associated with inlets formed by draws. The rusty brown vegetation is cockleburrs and the yellow vegetation is cottonwoods.

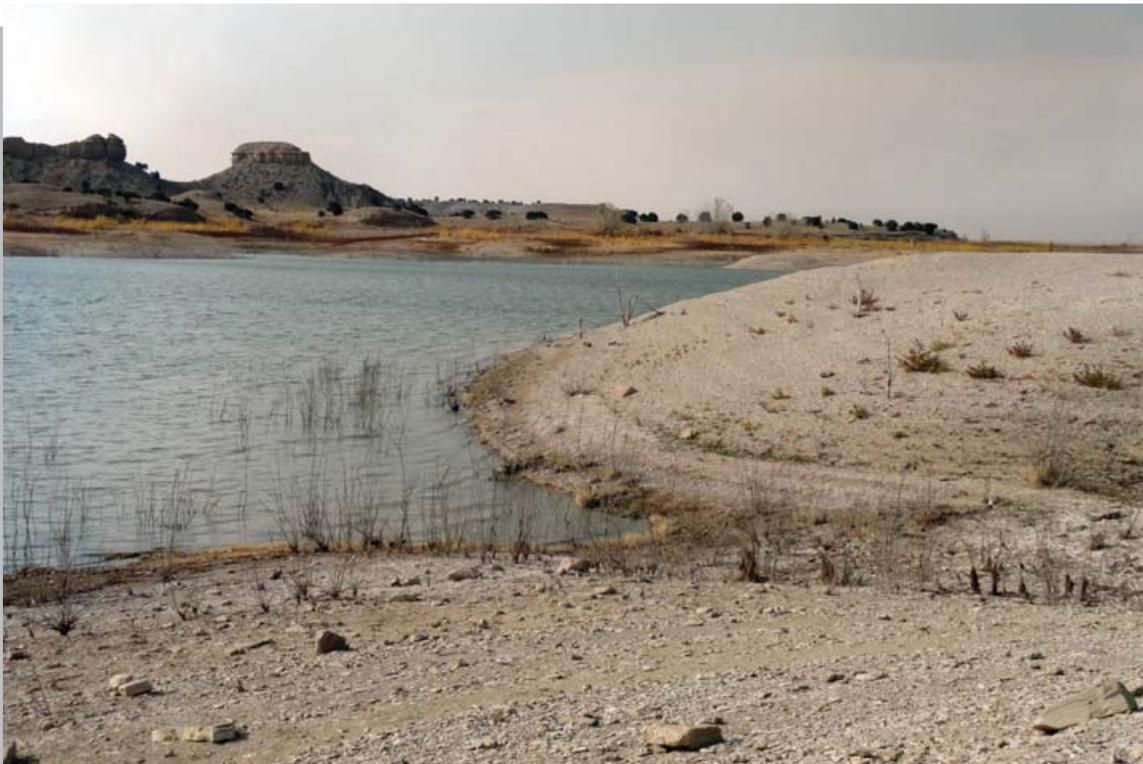
Pueblo
Reservoir

Photo 30 - Relatively bare fluctuation zone in the foreground with patches of cockleburrs (rusty brown) and cottonwoods (yellow) in the background associated with draws and inlets.

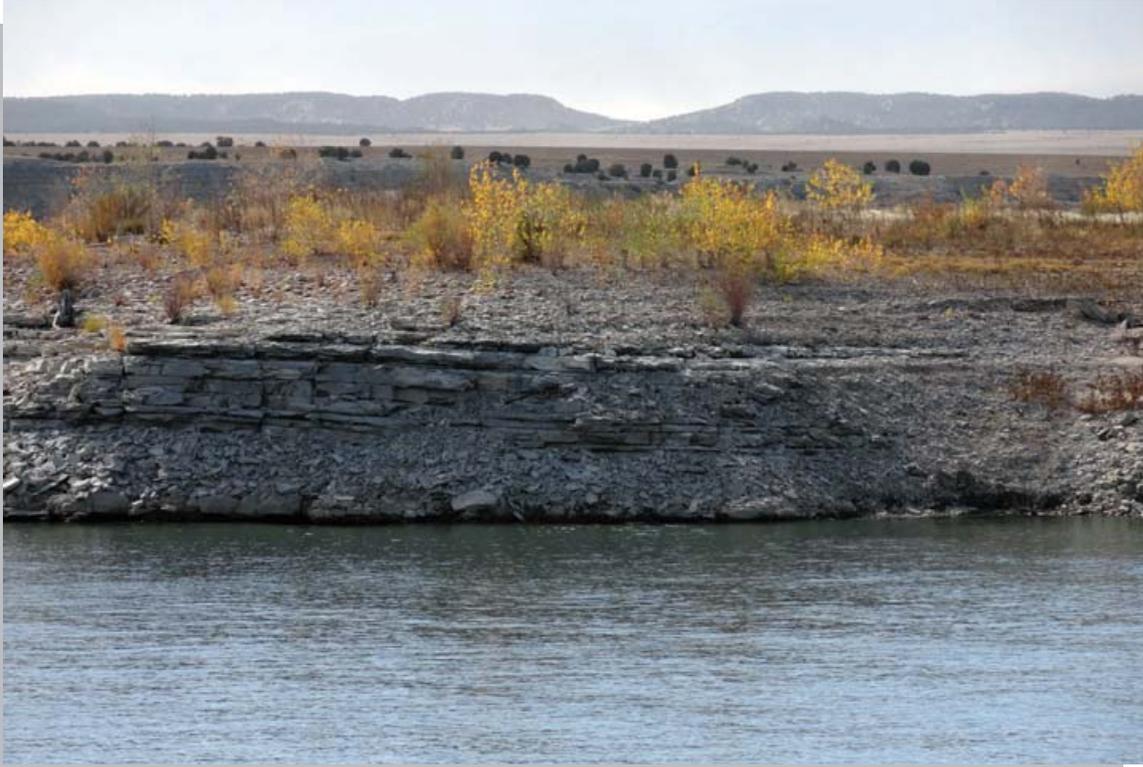
Pueblo
Reservoir

Also of note is the common occurrence of plains cottonwoods and coyote willows on top of the cliffs that border the reservoir (Photo 31). It is clear from erosion, soils, and drift deposits that the tops of these cliffs are inundated, at least briefly, during periods of high-water levels; however, these areas were 20 to 25 feet higher than reservoir water levels at the time of the site review.

Photo 31 - Cottonwoods established at the top of the fluctuation zone about 20 to 25 feet above the water level.
