Appendix N
Chatfield Marina
Reallocation Impact Assessment Report

Reallocation Impact Assessment Report

Chatfield State Park - Littleton, CO

February 2011

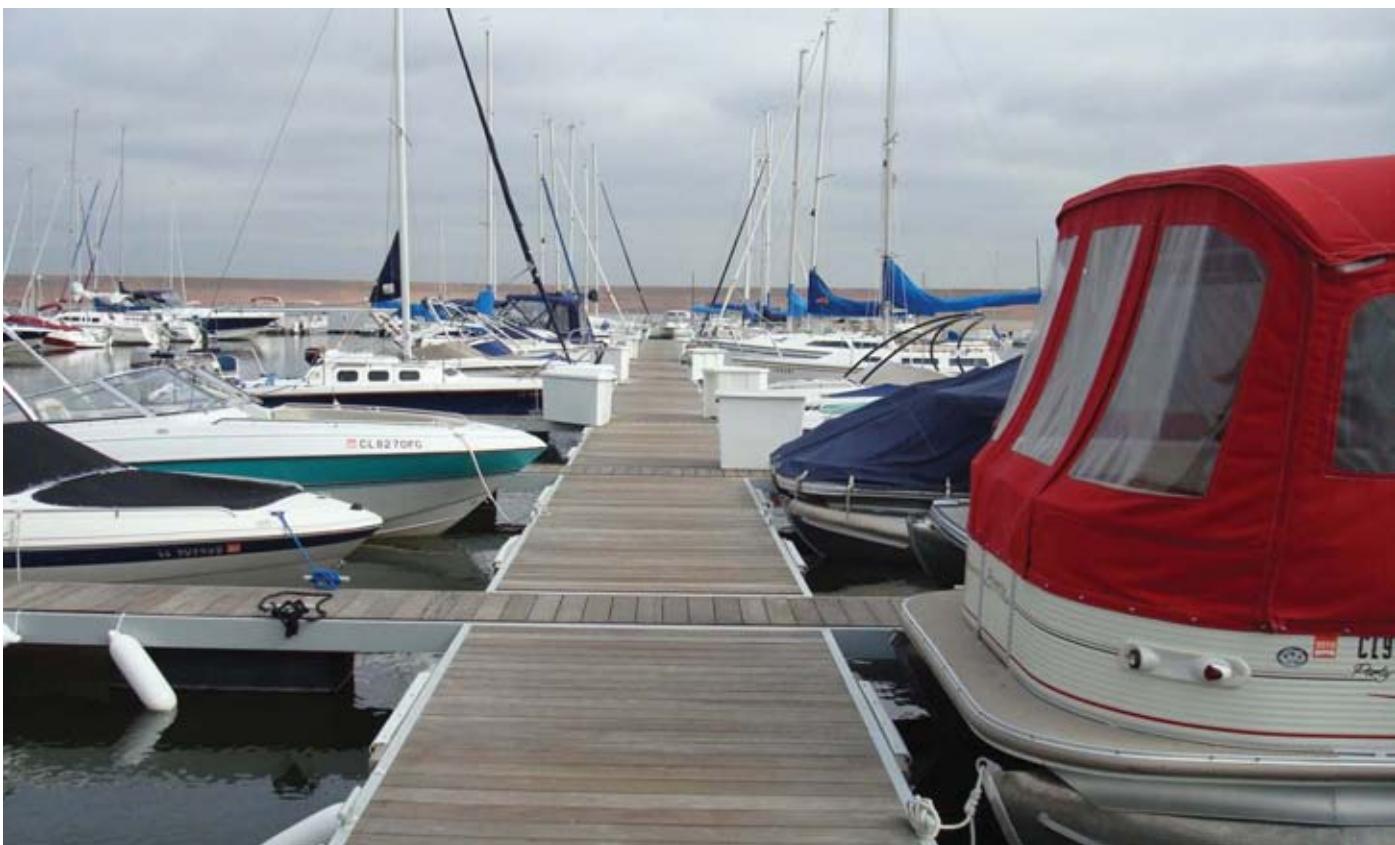
3-3 Floating Docks

The existing floating dock system was built by the operator incrementally over the last 27 years. The dock system consists of welded tube steel frames, polyethylene encased polystyrene floats, and Ipe (sustainable Brazilian hardwood) decking. The frames have field welded connections along the mainwalks and hinged connections at finger and secondary platform connections. The shallow nature of the tube frames results in significant flexure (bounce) of the dock system when subject to pedestrian loads. The frames, floats, and decking are all in excellent condition and have been carefully maintained.

Replacement of the dock system with a new one will allow for a more robust system that will withstand the more exposed conditions and the increased loadings from wave and ice conditions.

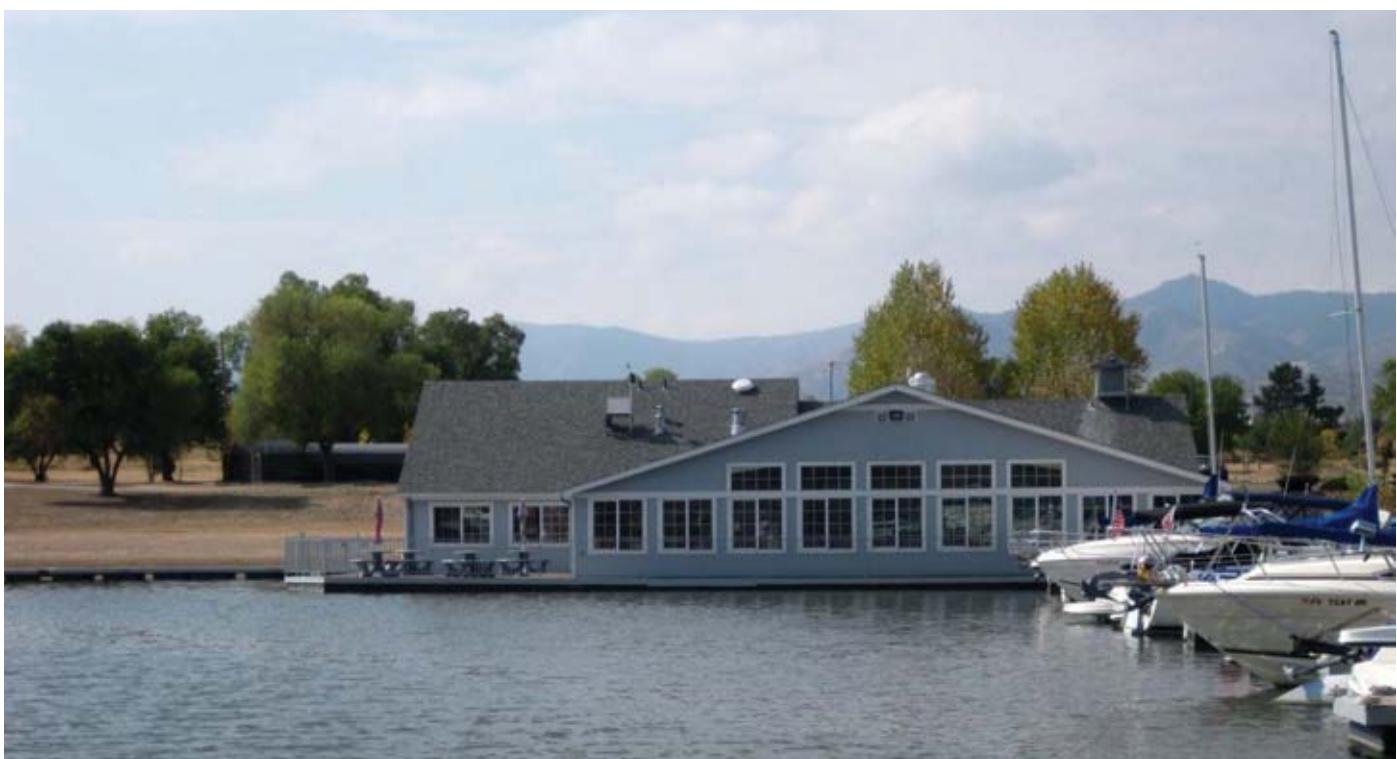
3-7 Floating Office/ Restaurant/ Restrooms

The 64 sf fuel dock building provides an area for fuel payment transactions and storage of fuel dock related equipment. It is supported by the floating dock system and provides basic service similar to most marinas.

A replacement for the existing floating platform based office, convenience store, and restaurant is recommended. The fuel system should be modified to provide USTs above the 50 year flood level. This would simplify the tank fill procedure and would increase safety for the facility. Replacing the fuel system with a system similar to existing was discarded since, the distance from the new roads to any dock mounted AST would be impractical in either of the proposed alternatives.

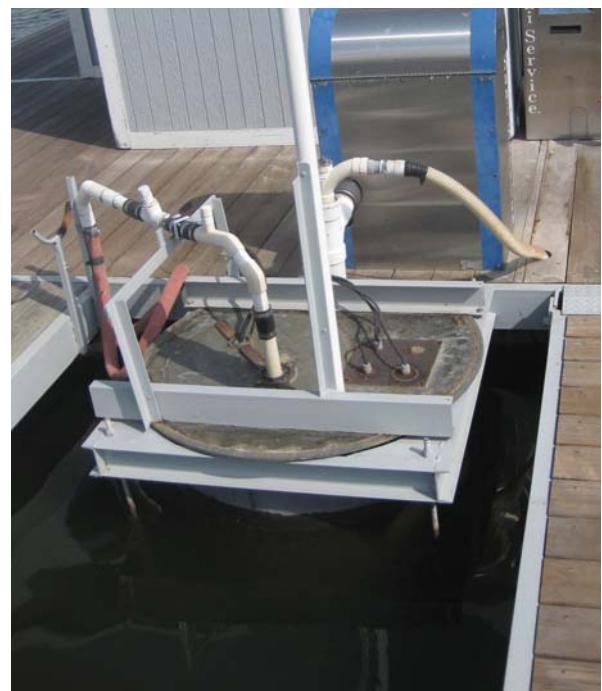
3-11 Pump Out Station

The Pumpout fixture is supplemented by a dock mounted lift station. This boosts the pressure and deposits the waste in a floating platform lift station that discharges the waste to the upland lift station.

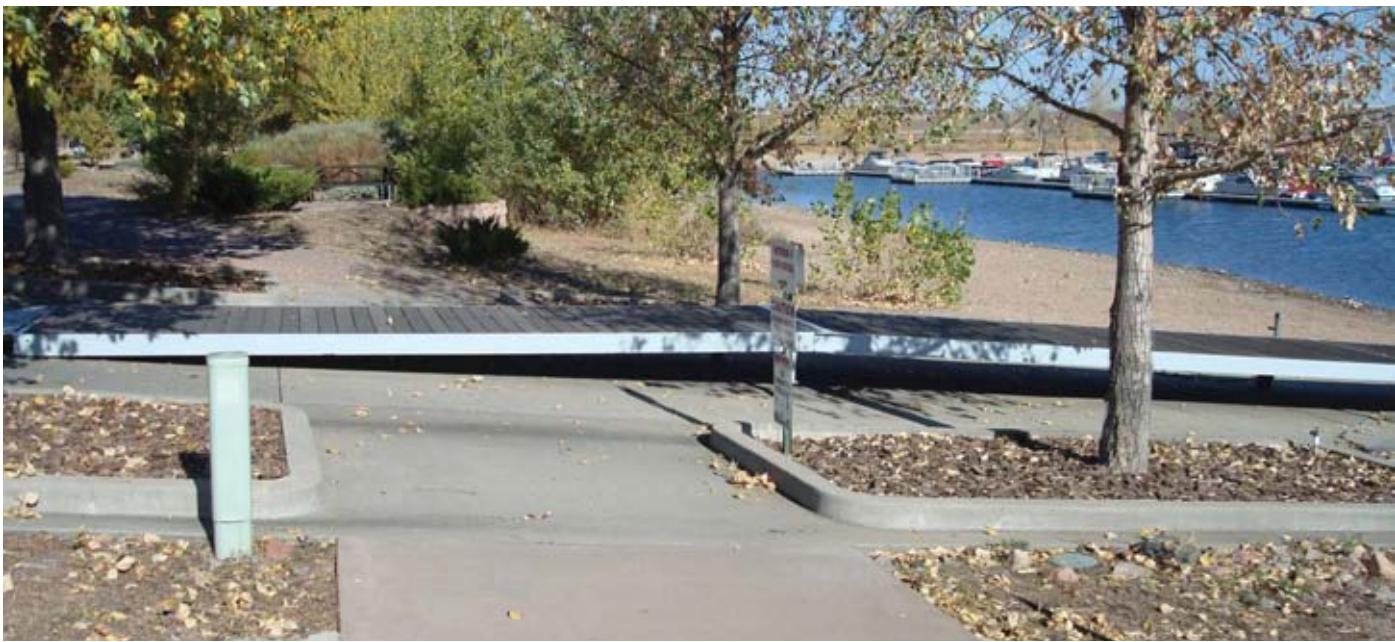
3-14 Gangway Approach

The primary access to the floating marina is by a 150' long articulated floating walkway that rests on a concrete accessway during low water conditions. The gangway functions until the water elevation reaches 5440'. No security gates are provided on the gangway, but access is through a gate located on the floating restaurant platform.

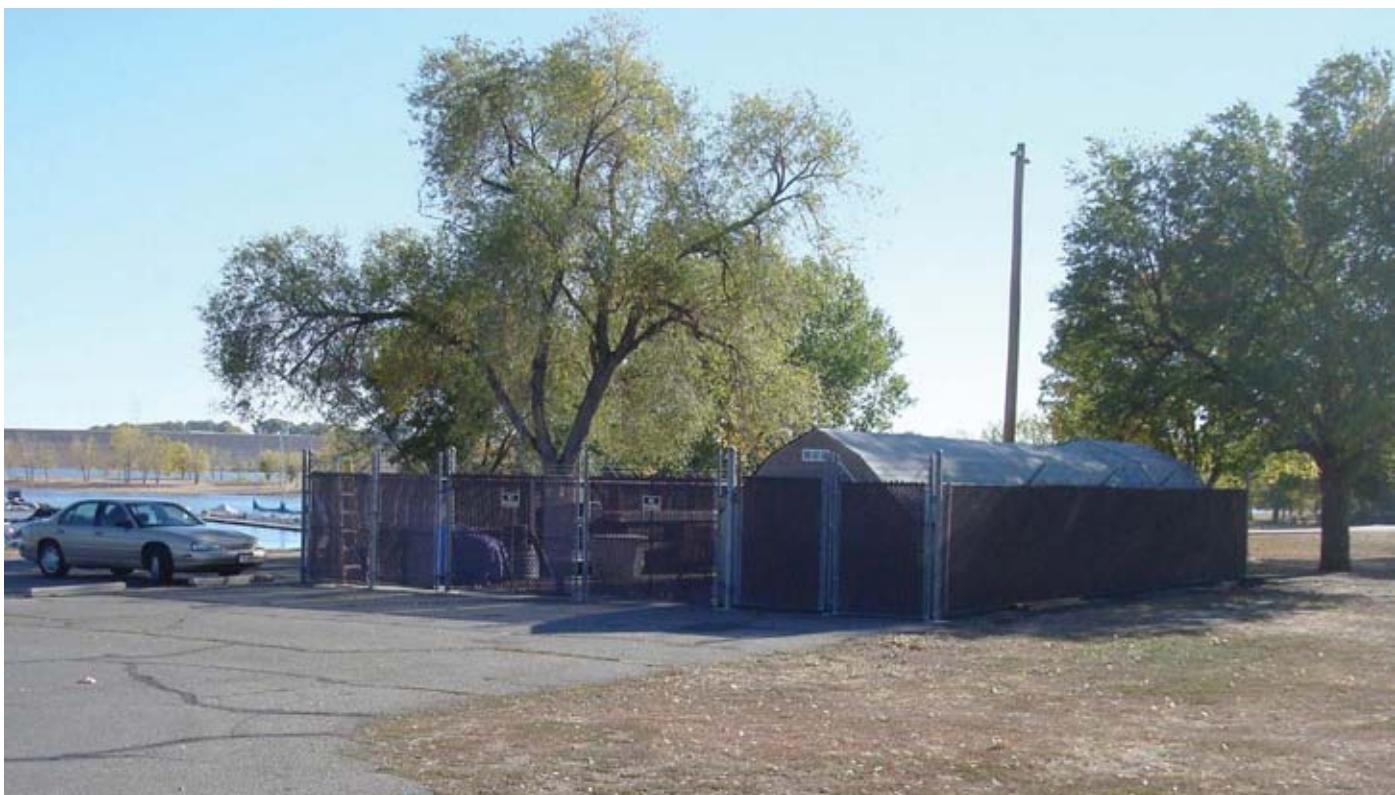
3-18 Marina Storage Yard

The marina has a fenced storage yard at the east end of the parking lot that provides a secured area for maintenance equipment and for paddleboat storage during the off season.

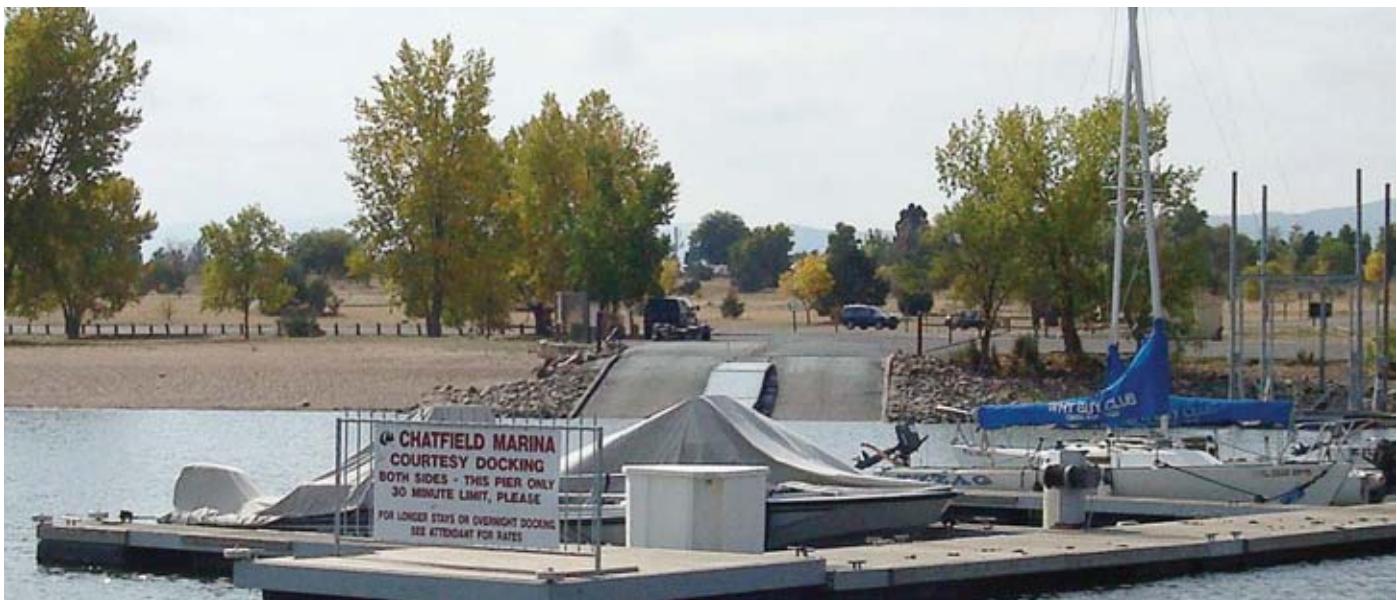
3-23 Launch Ramp

The South Launch ramp provides an alternative launch point to the larger North Ramp and is used for service and storage access at the marina. The parking lot adjacent to the ramp is separated from the marina users parking area.

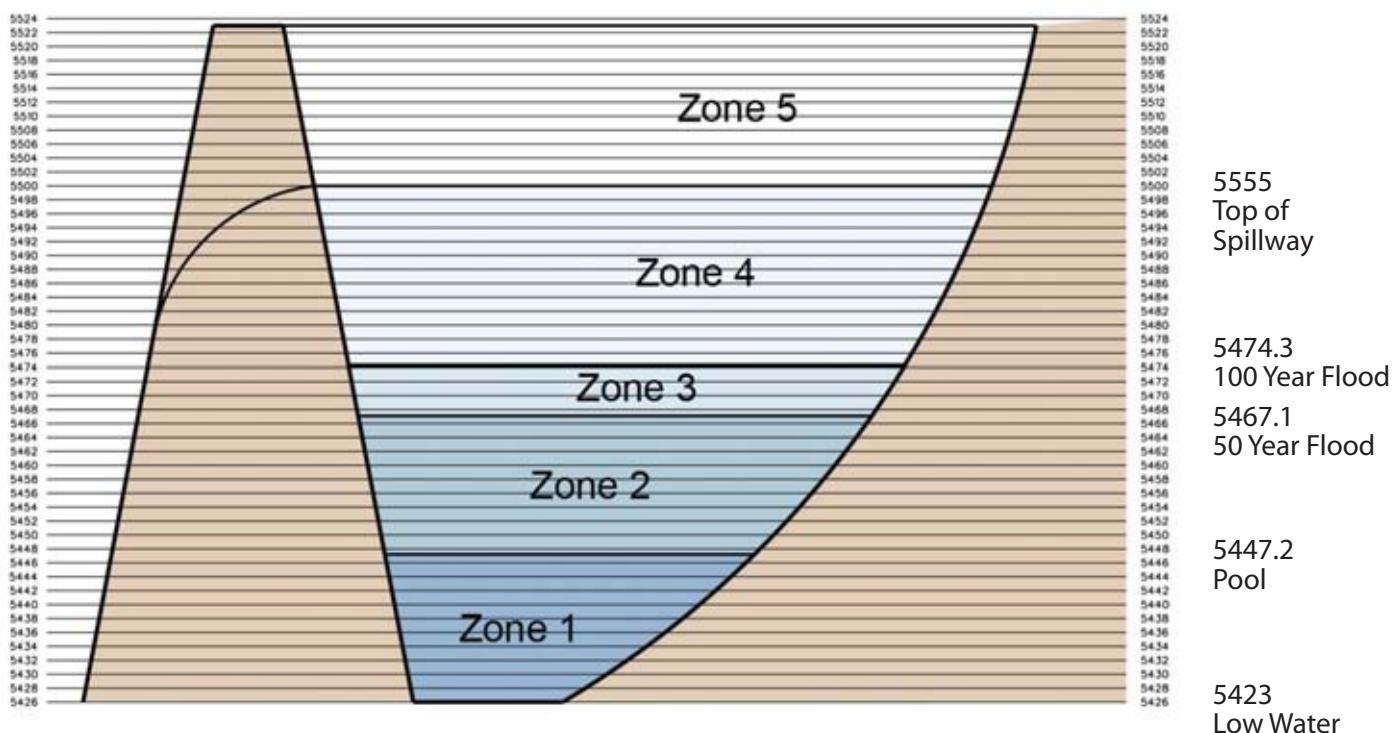
4-1 USACE Land Development Guidance Zone Section

The Land Development Guidance at Corps Reservoir Projects report (Reference 1) dated April 30, 2004 provides assistance for the appropriate siting of facilities such as Chatfield and restricts development below various elevations. The guide is very specific in the types of structures allowed.

In a letter from the USACE Hydrologic Research Branch dated January 29, 2009 a conditional waiver of placing structures in the upper region of Zone 1 (5,447' to 5,453' MSL) was granted for some parts of the State Park, although the marina structures were not included. Other facilities associated with the State Park and Reservoir have not been evaluated for flood damage expectations in the Chatfield Reservoir Recreation Facilities Modification Plan (Reference 3). The plan, prepared by EDAW/AECOM in January 2010, ignores the impact of water elevations above FWSP on the marina related facilities.
