KINGFISHER AREA PHOTO SIMULATION

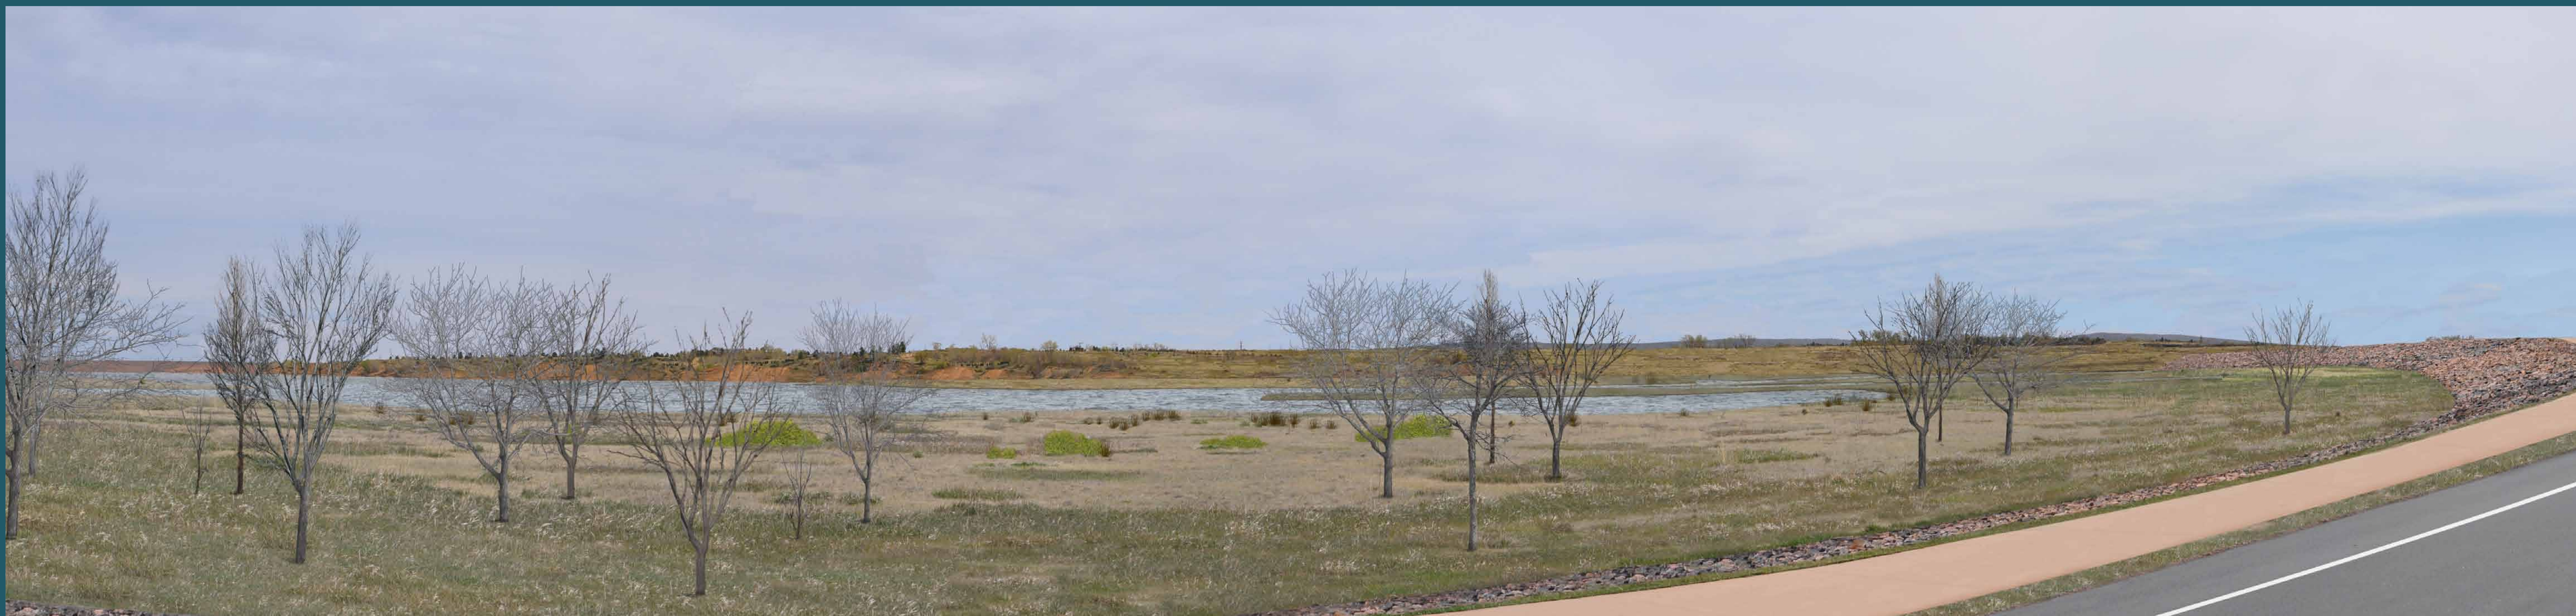
Post Reallocation - Water Level at 5432': Simulation depicts tree clearing up to 5439' and conceptual mitigation approximately 5 years after implementation.

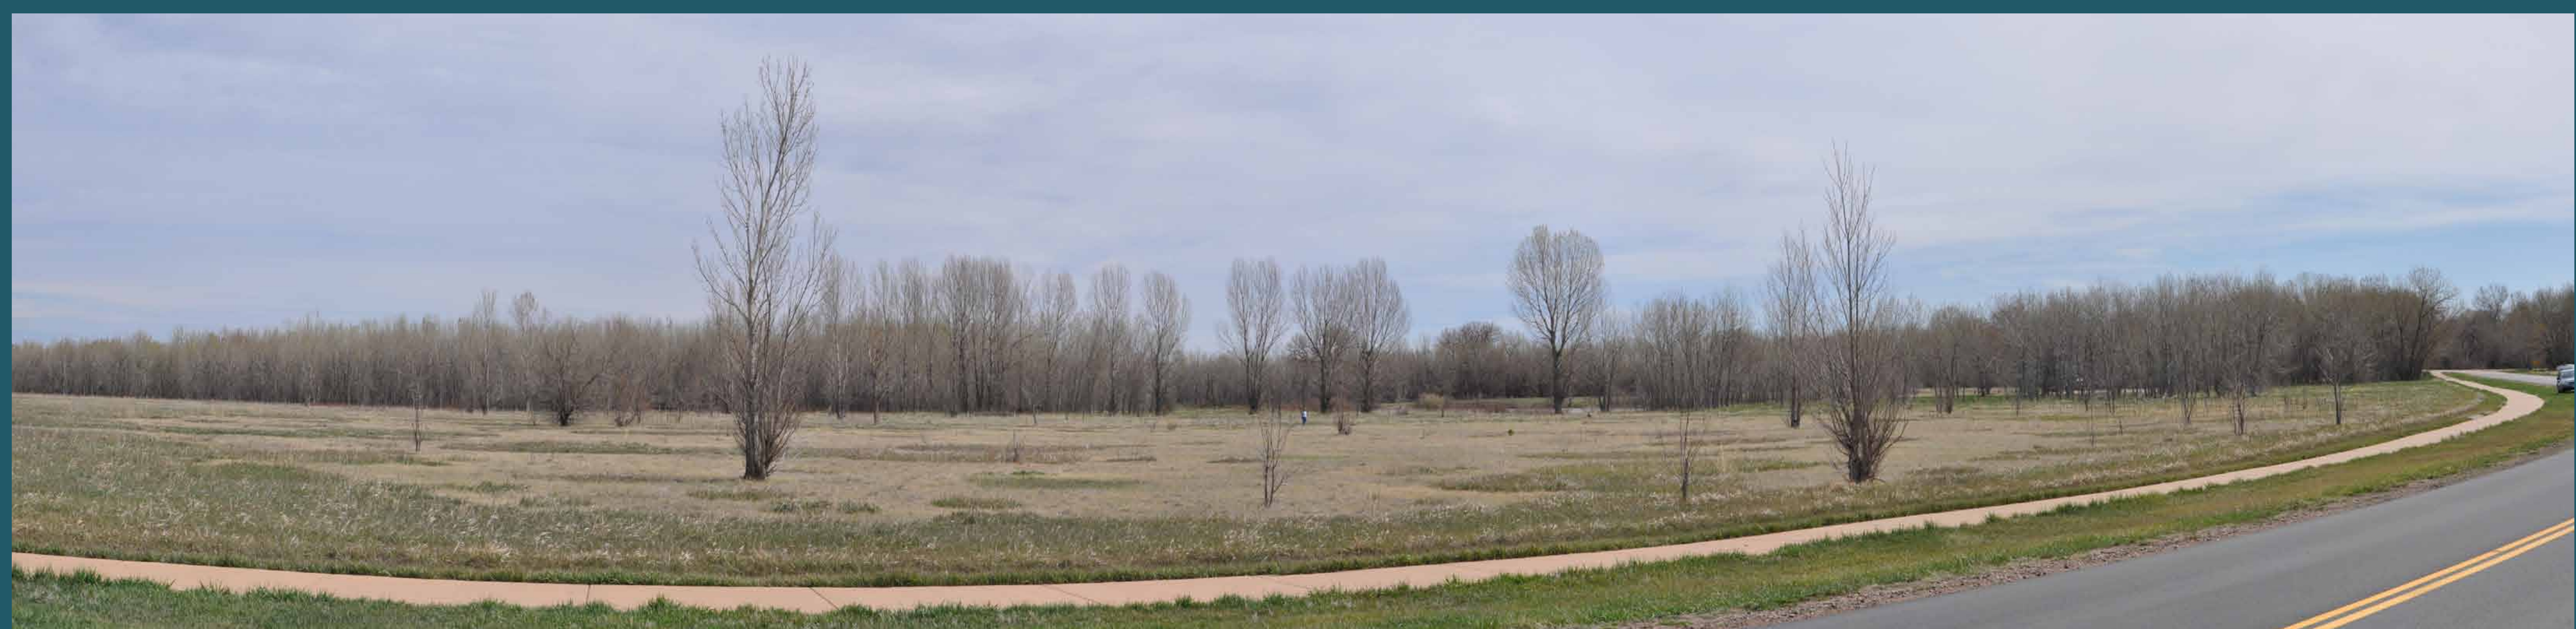
Existing Conditions: View from the Park Road looking towards the reservoir in the Kingfisher Area

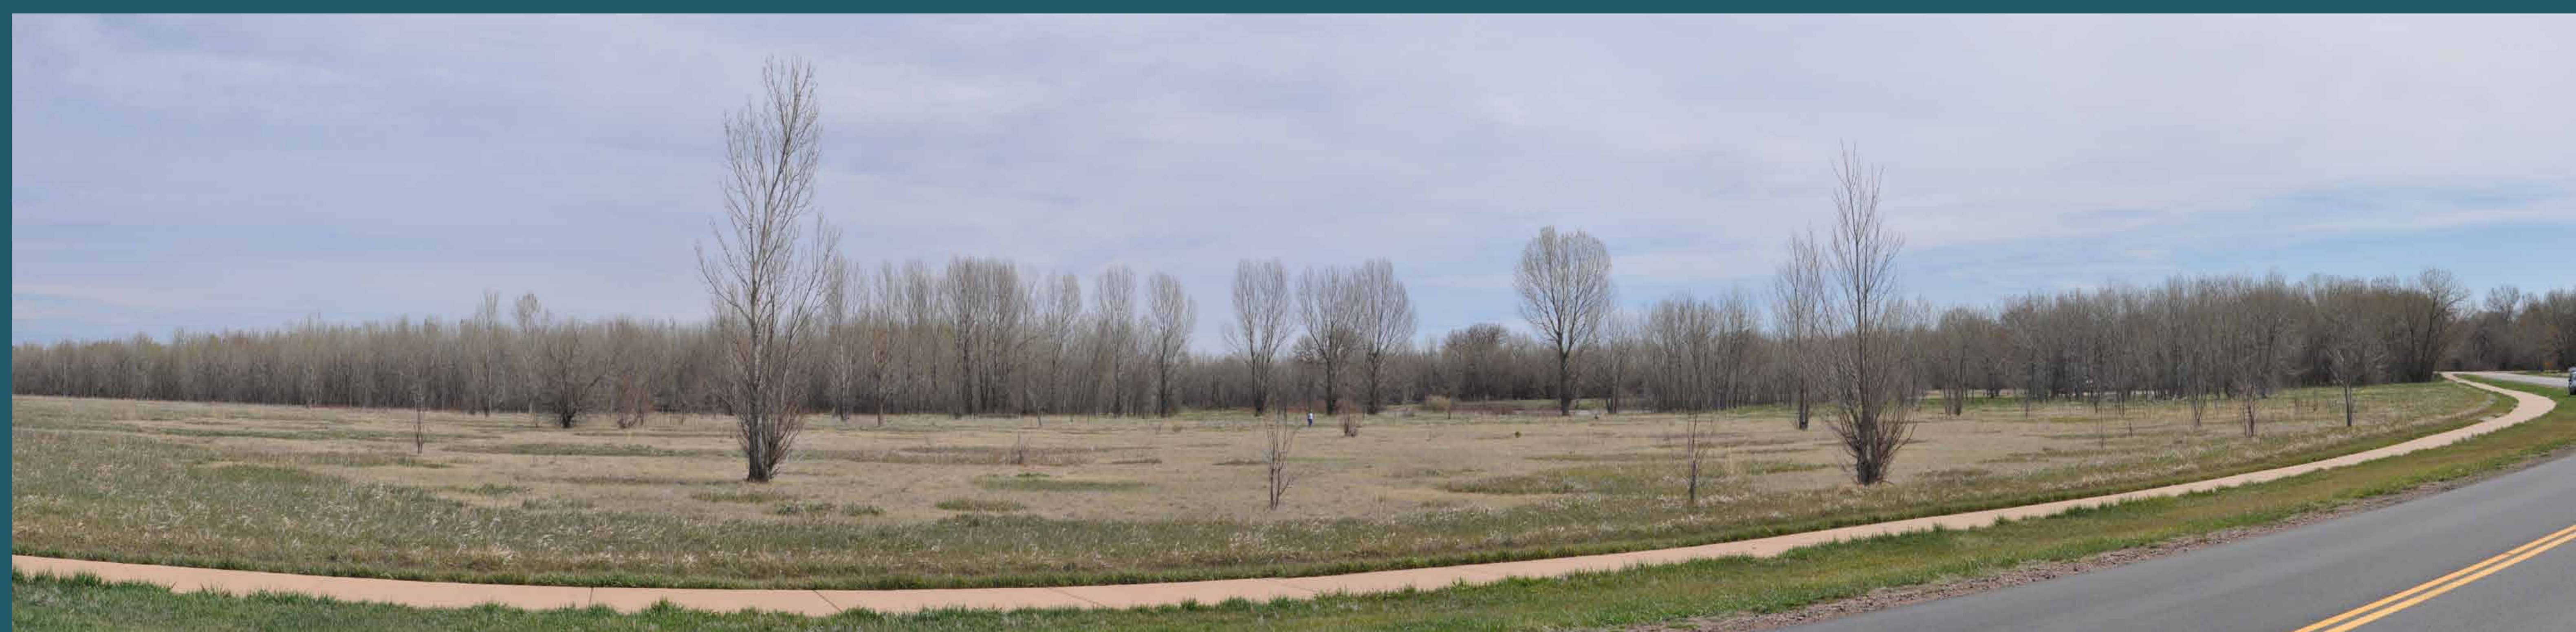
Existing Conditions: View from the Park Road looking towards the reservoir in the Kingfisher Area
