NORTH BOAT RAMP PHOTO SIMULATION

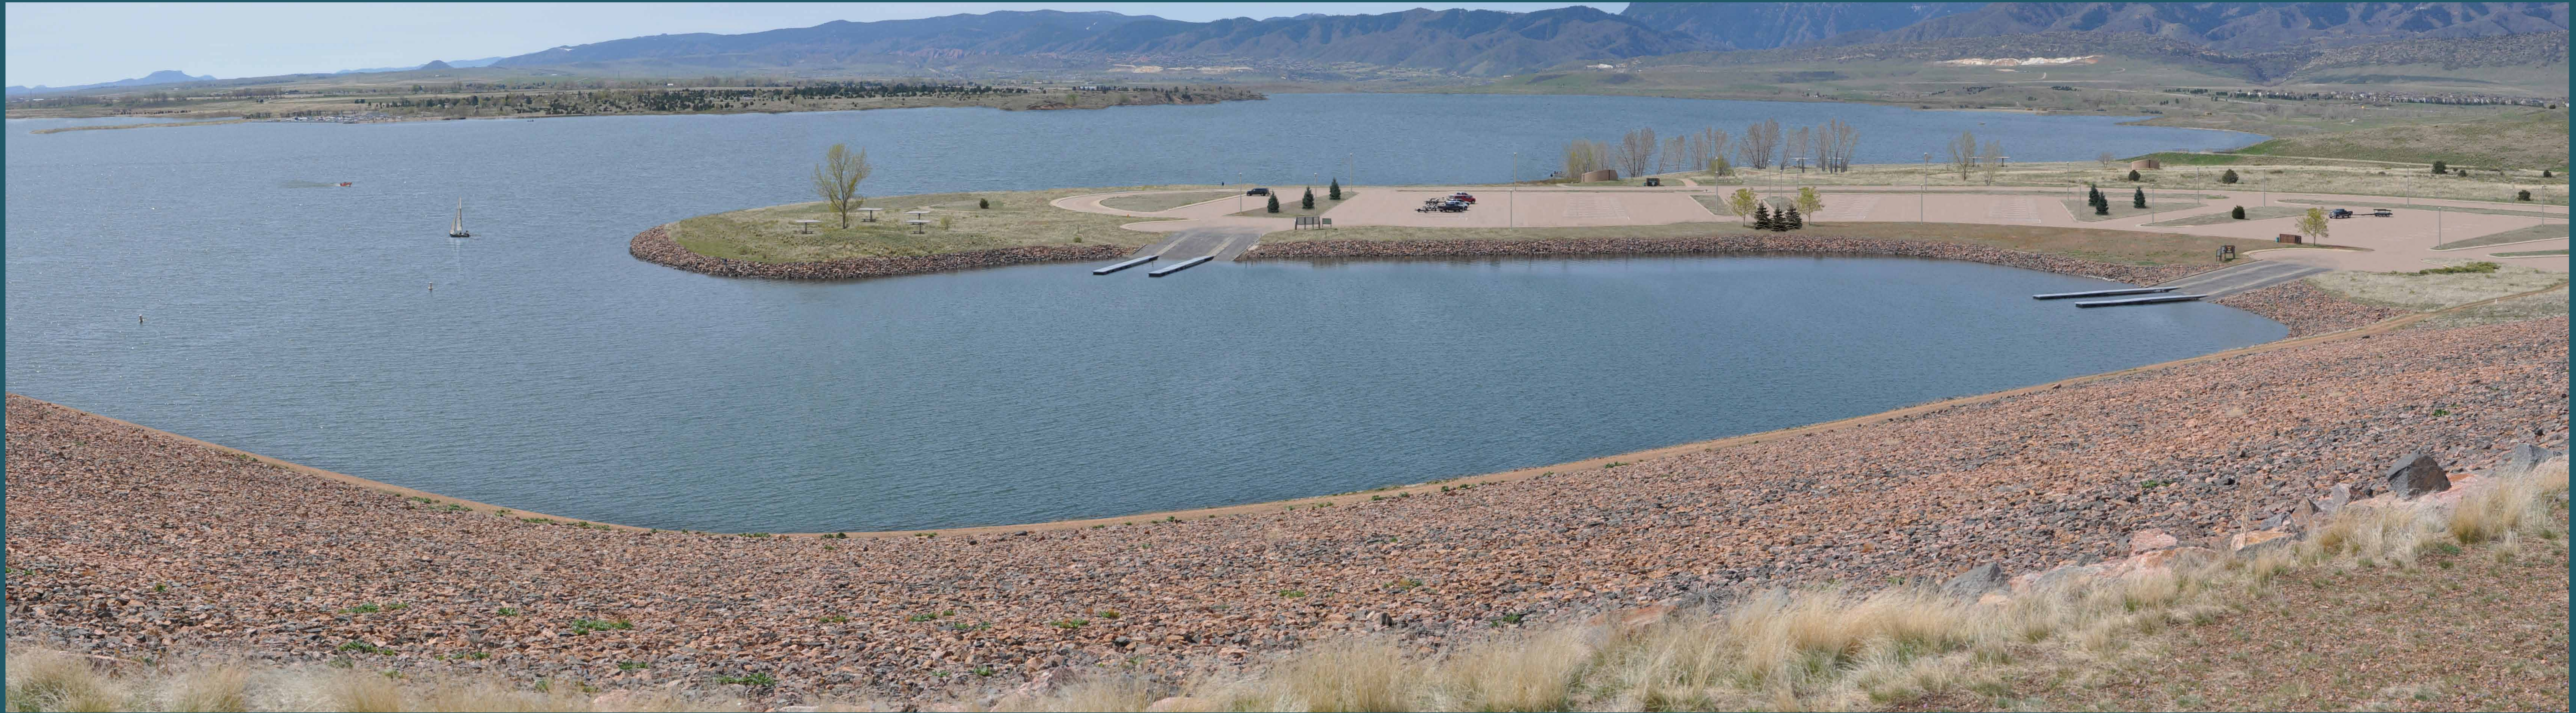
Post Reallocation - Water Level at 5444': Simulation depicts tree clearing up to 5439' and conceptual mitigation approximately 5 years after implementation.

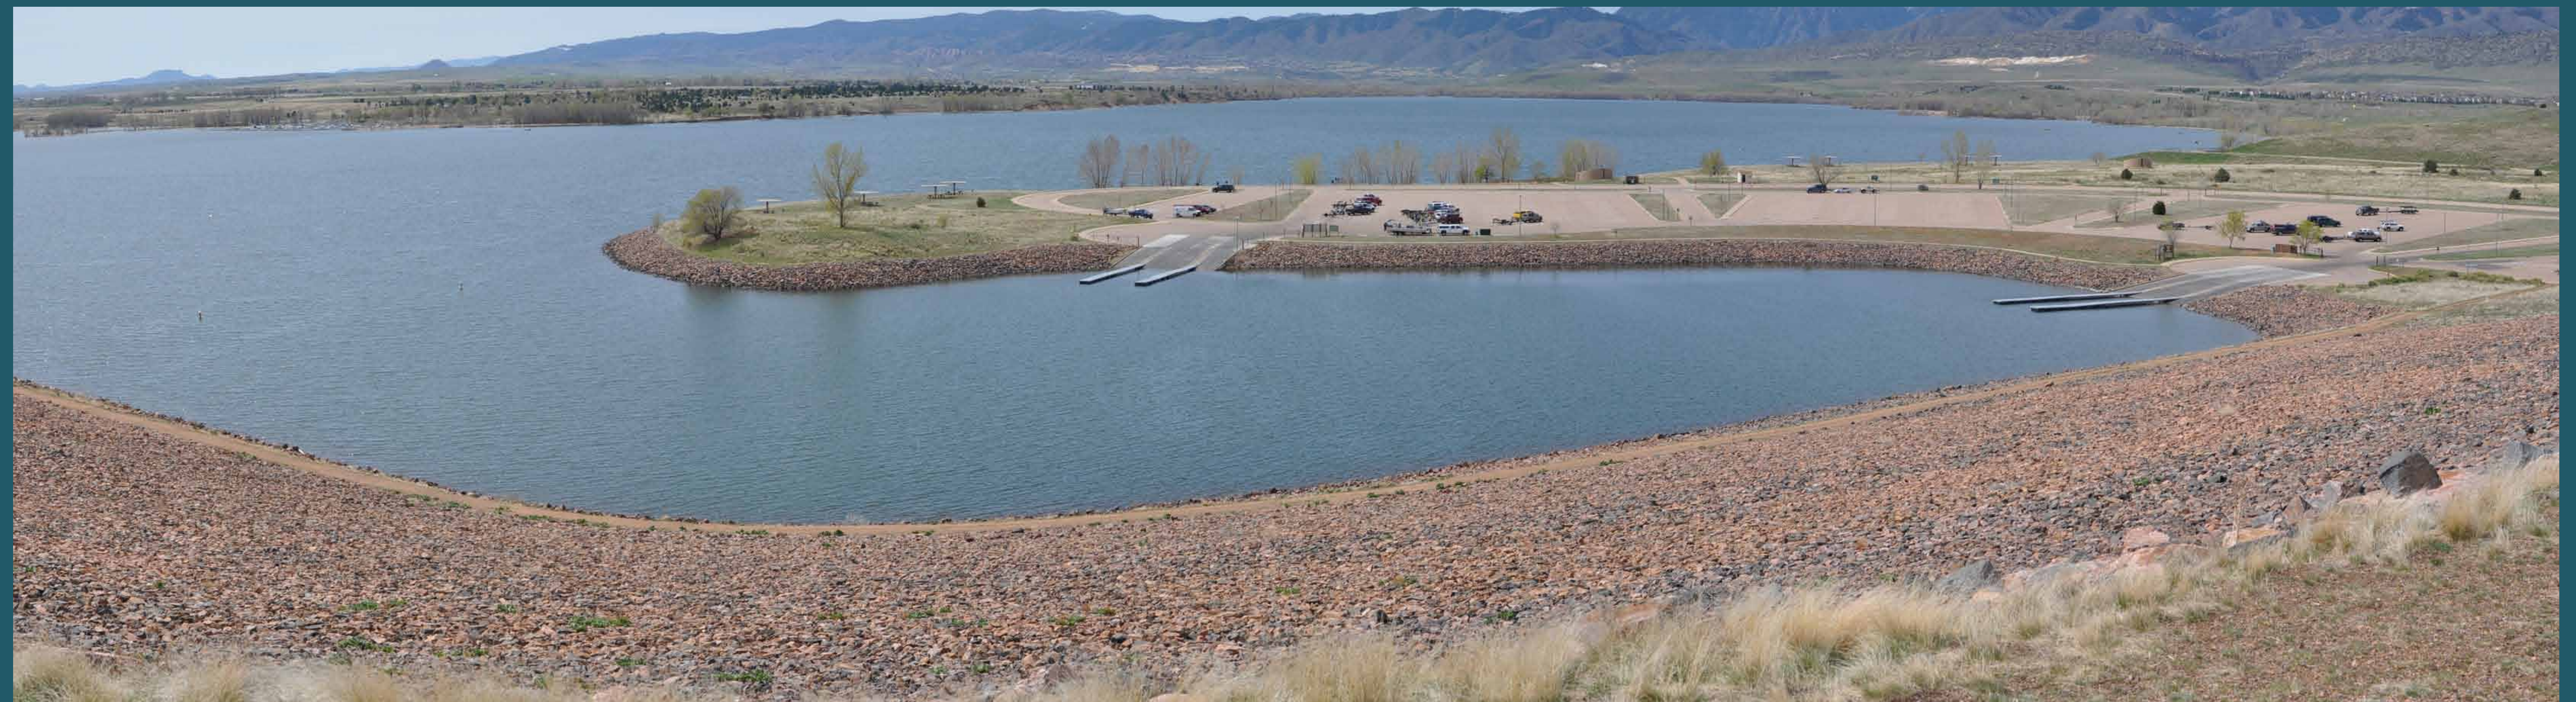
Existing Conditions: View from the Dam Overlook towards the North Boat Ramp with the water level at approximately 5432'
