Modification Plan

PLUM CREEK PHOTO SIMULATION

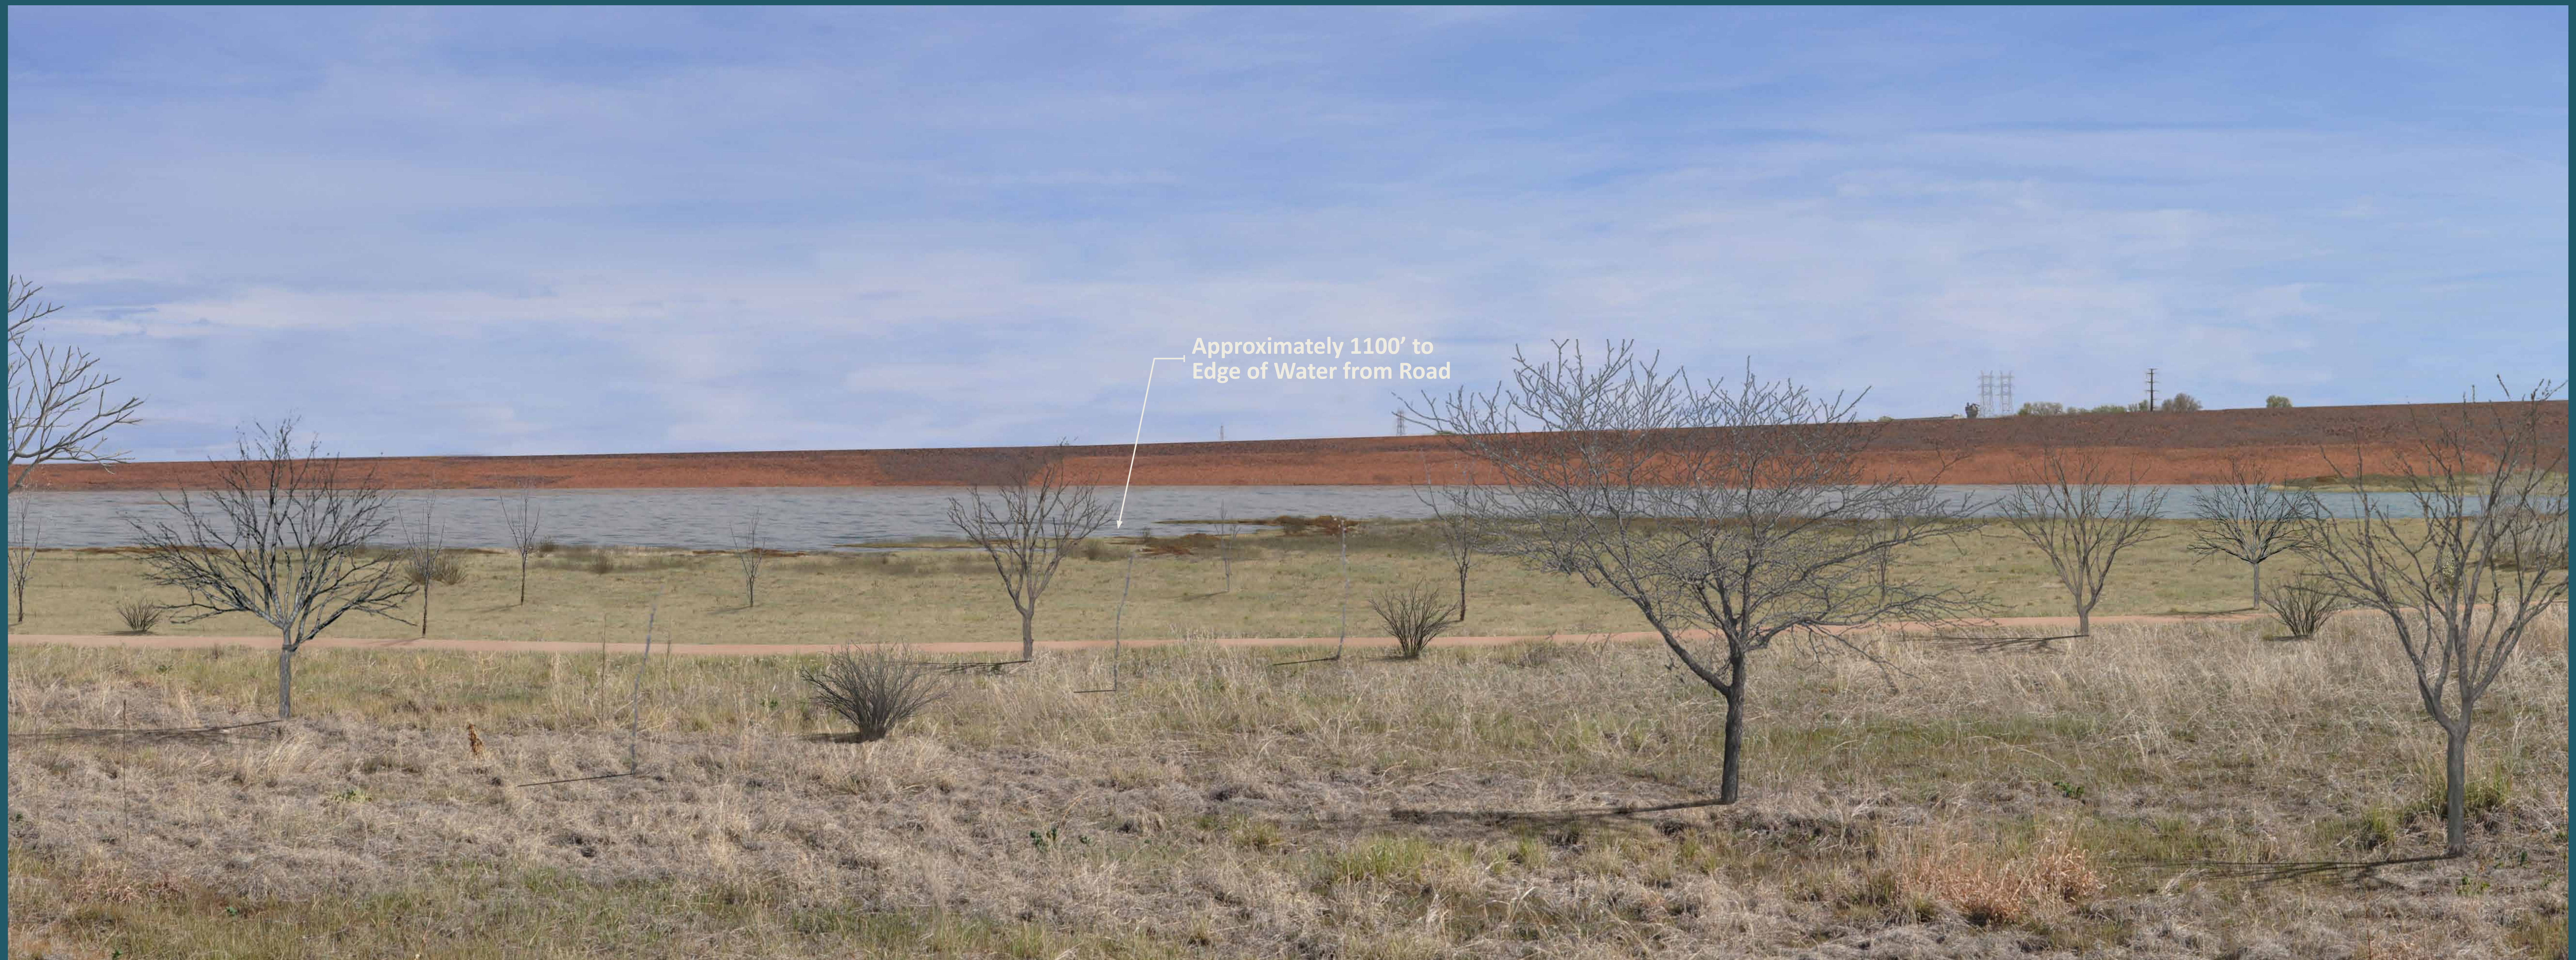
Post Reallocation - Water Level at 5432': Simulation depicts tree clearing up to 5439' and conceptual mitigation approximately 5 years after implementation.

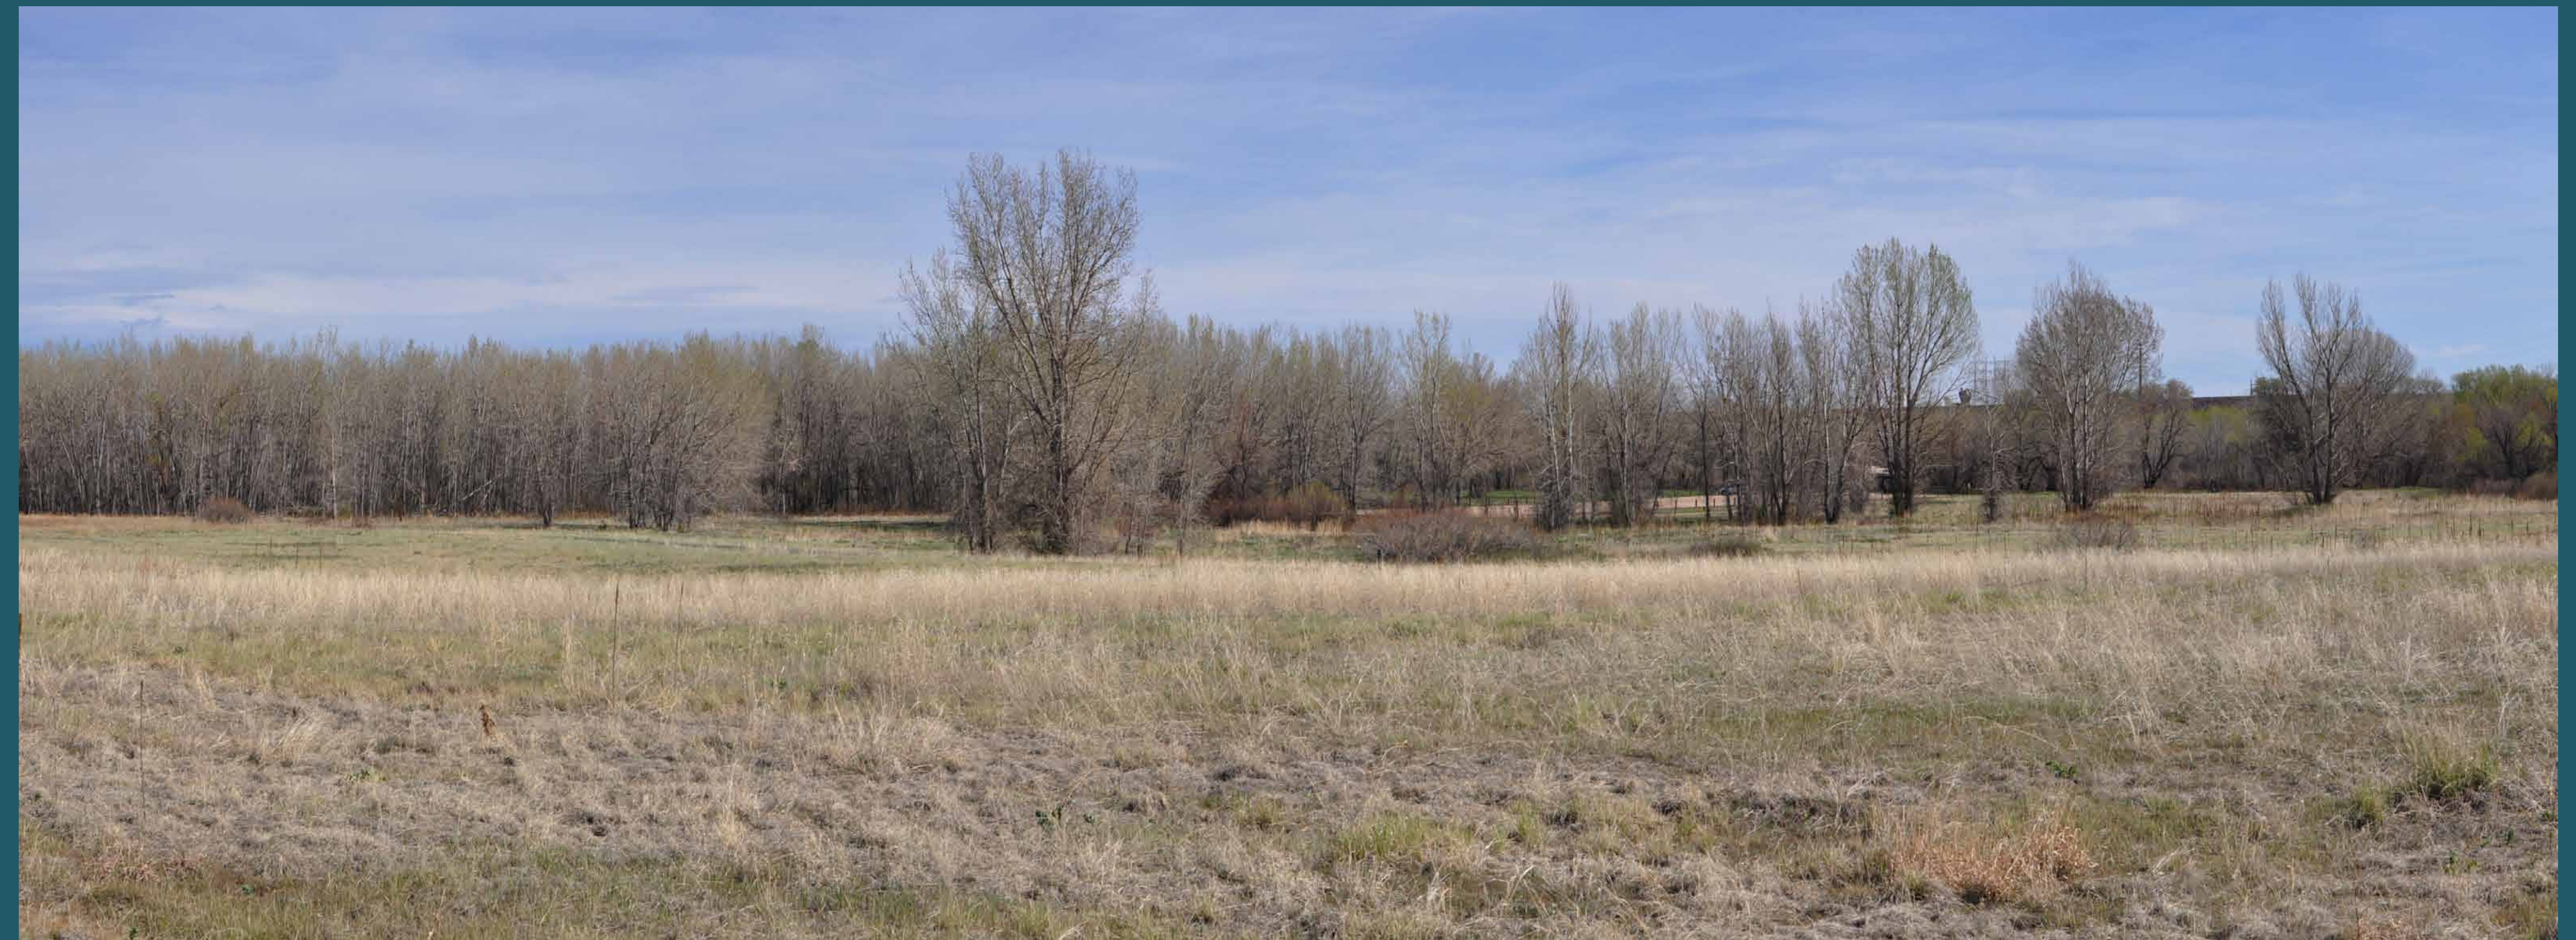
Existing Conditions: View from the Park Road looking towards the current Day Use Area

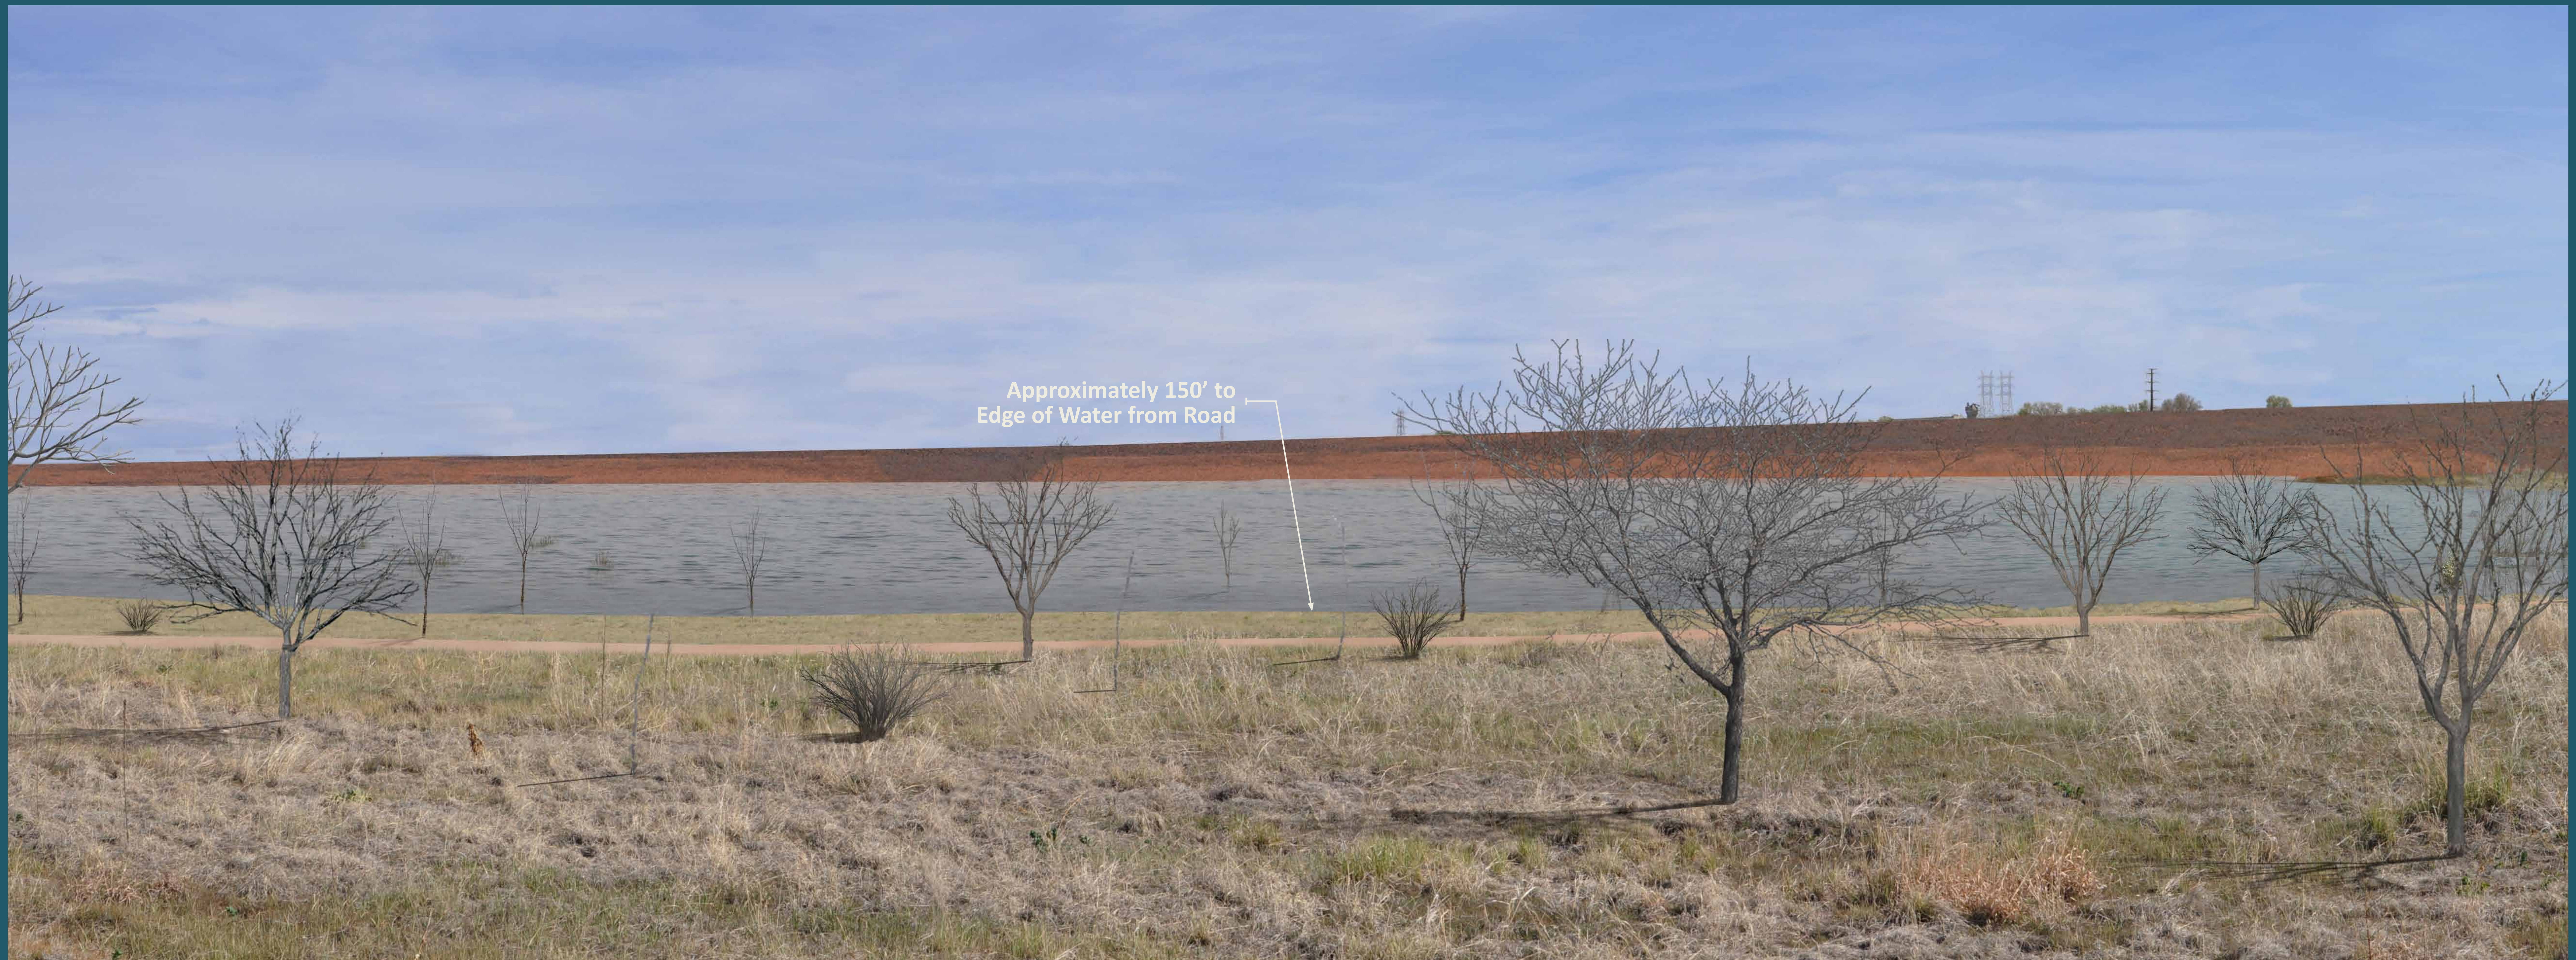
Approximately 150' to
Edge of Water from Road

Post Reallocation - Water Level at 5444': Simulation depicts tree clearing up to 5439' and conceptual mitigation approximately 5 years after implementation.

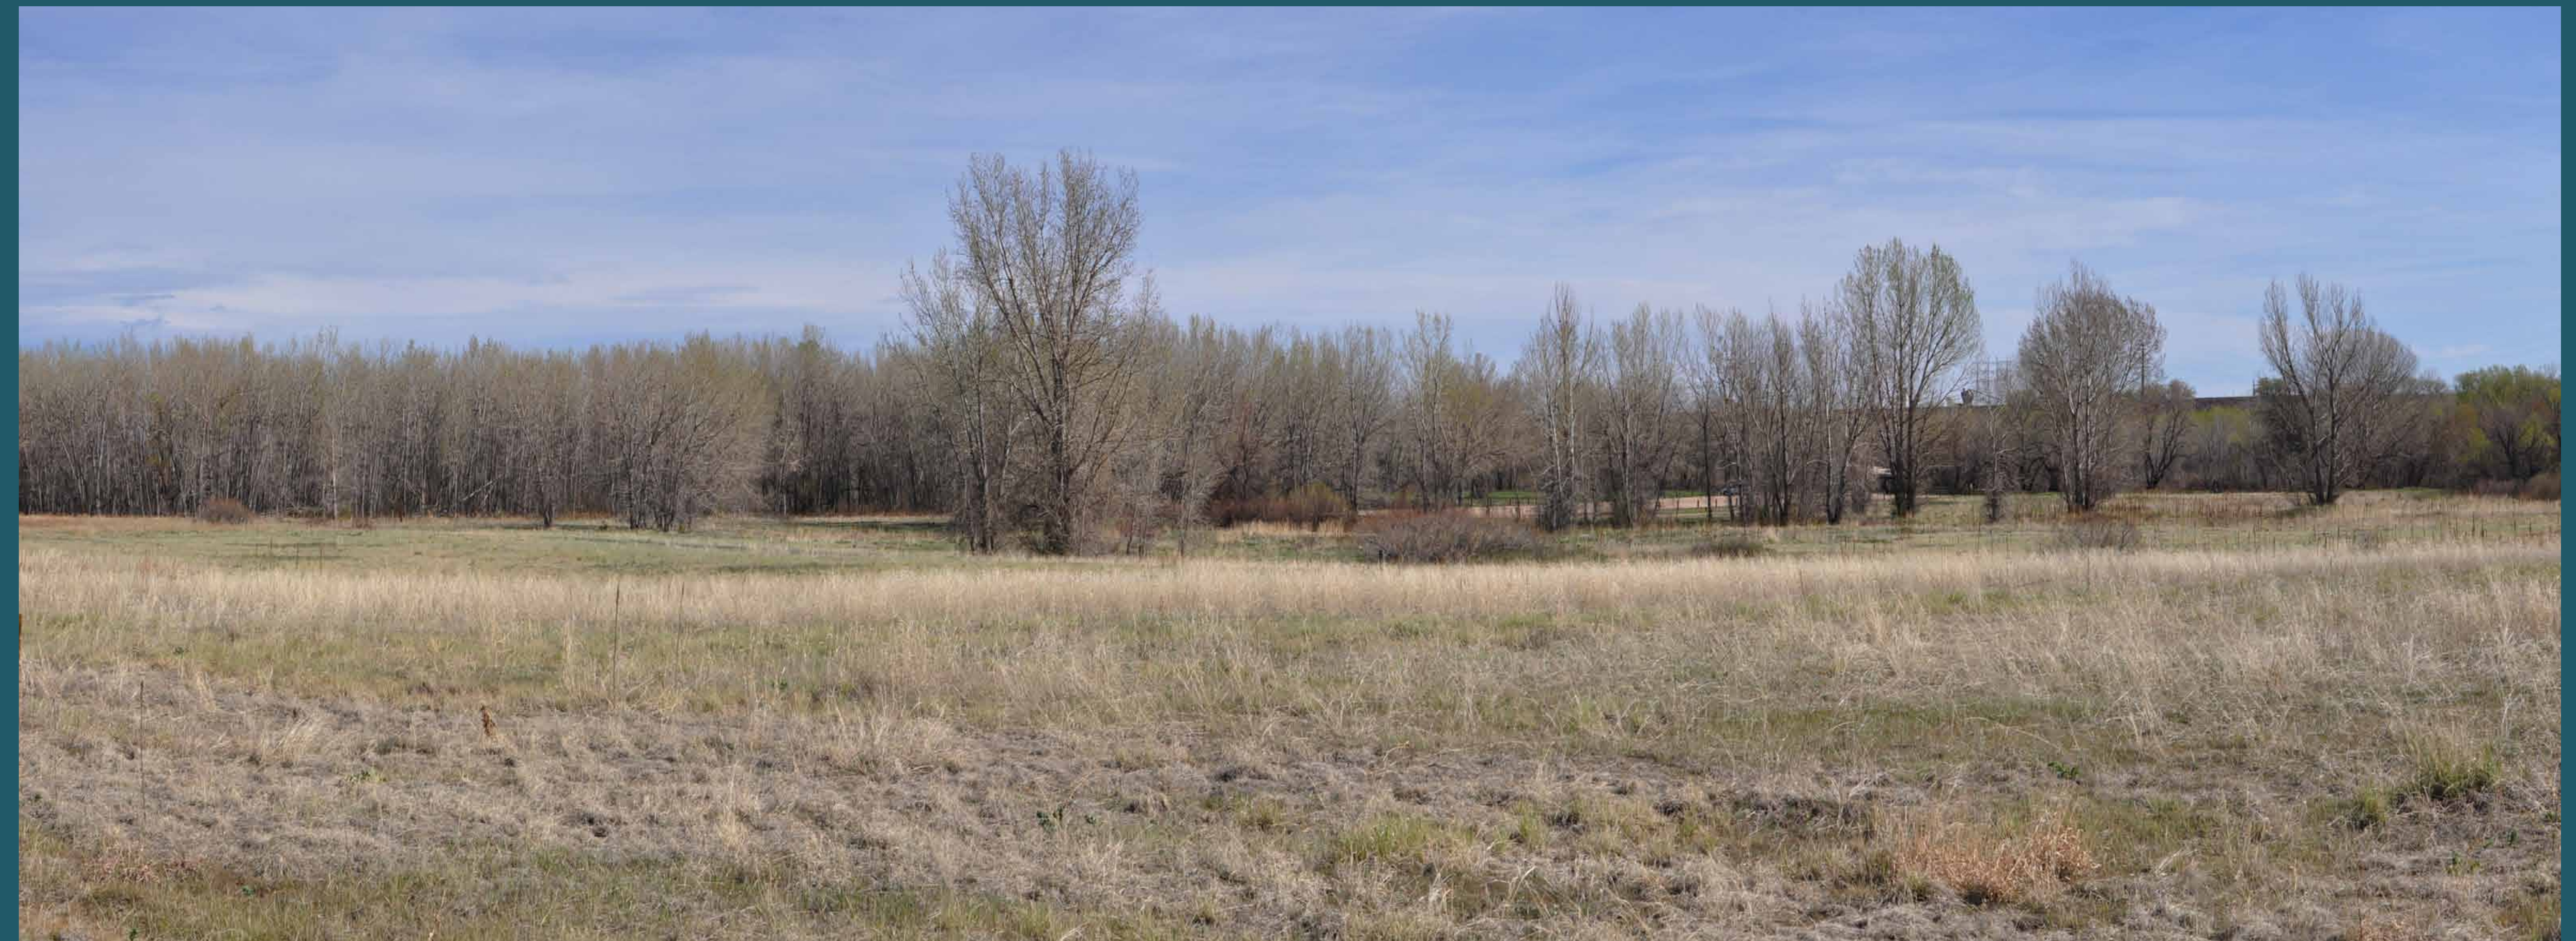
Existing Conditions: View from the Park Road looking towards the current Day Use Area
